BUILDING INSPECTION REPORT

NATIONAL INSPECTION SERVICES

**INSPECTION ADDRESS: 5225 Abbey Road
Fort Collins, Colorado**

INSPECTION DATE: January 23, 2009

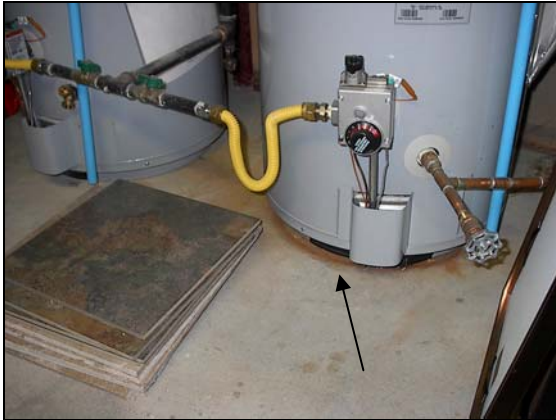
2. Rust stains were observed on the concrete floor beneath the water heaters. Both water heaters were operating as intended and had no evidence of internal rusting or active leaking. Due to the newer age and satisfactory condition of both water heaters, these rust stains appear to be from a prior event and are inconsequential.

Rust stains appear to be from a prior event and are inconsequential.

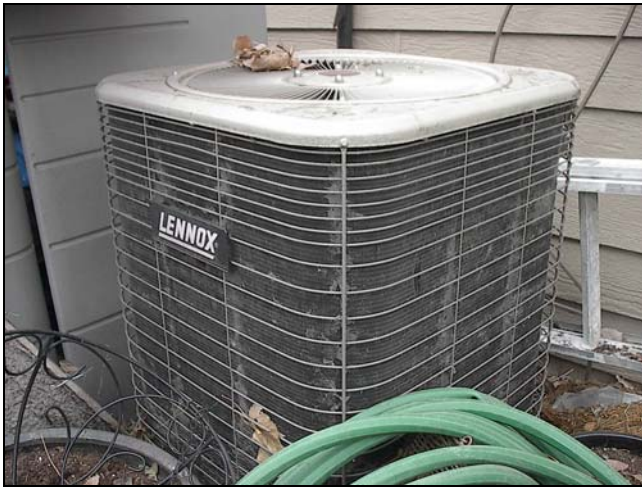
4. Condenser fins of System #2 exterior condenser require cleaning for the system to run more efficiently.

Condenser fins of System #2 exterior condenser require cleaning

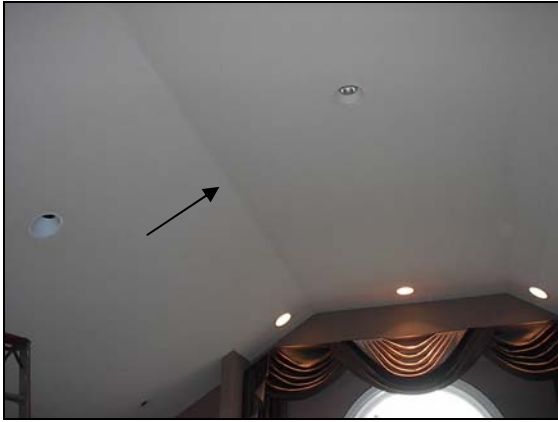
5. Ceiling in the living room and the intersection of the wall and ceiling in the top floor exercise room display cracking. These cracks appear to be inconsequential and not indicative of a chronic or degenerative condition.

Living room ceiling displays cracking

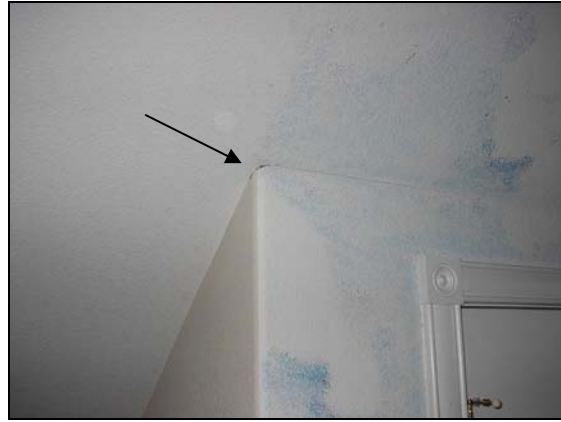
Cracking in exercise room

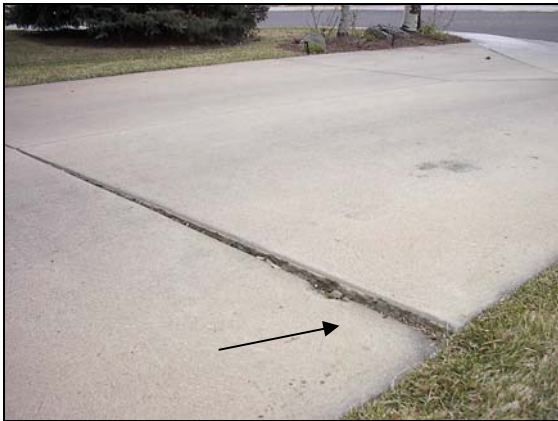
8. Driveway and front walkway display vertical displacement, which create possible trip hazards and require adjustments.
-

Displacement of driveway

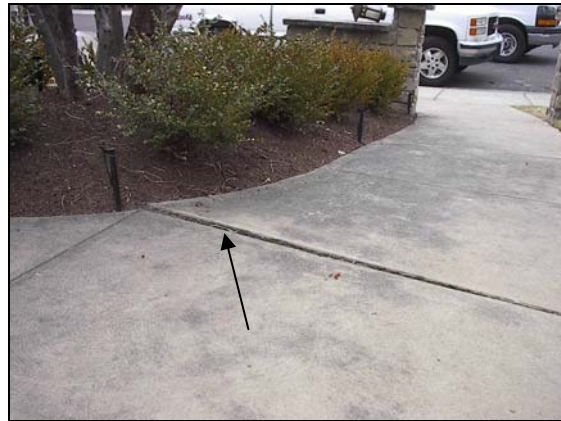
Displacement of front sidewalk

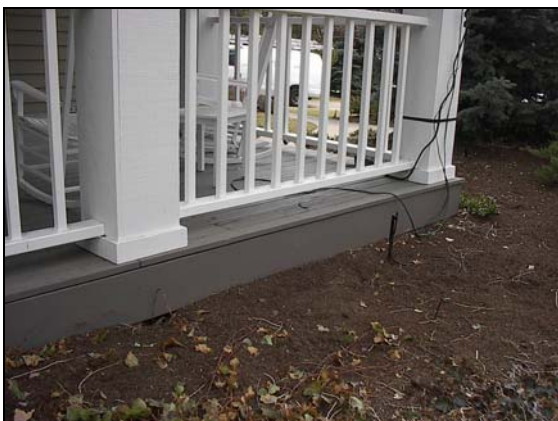
6. Representation about the comprehensive condition of the front porch deck cannot be made because the void beneath the porch was inaccessible and the deck could not be fully inspected.

Inaccessible front porch deck

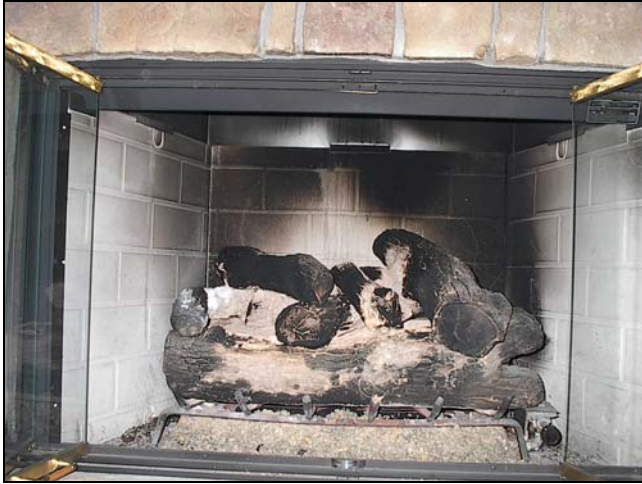
9. Discoloration of and soot on log set and fire box is typically indicative of improper venting, and/or incomplete combustion. In this instance, rearrangement of the movable logs appear to be the cause. Further evaluation by a qualified fireplace specialist may be necessary.

Soot on log set and fire chamber

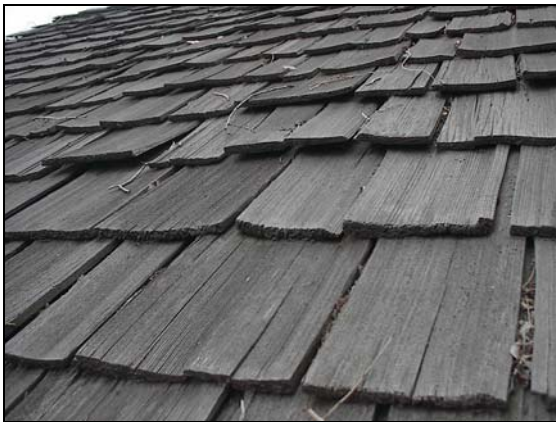
11. Worn wood shakes are typical of this roof's approximated age. Some curling and splitting is evident. Although the roof is showing signs of its age; it does not appear to be at the end of its service life. Selected shingle replacement may be needed as repair will extend the life of this roofing system.

Some curling, splitting and normal wear

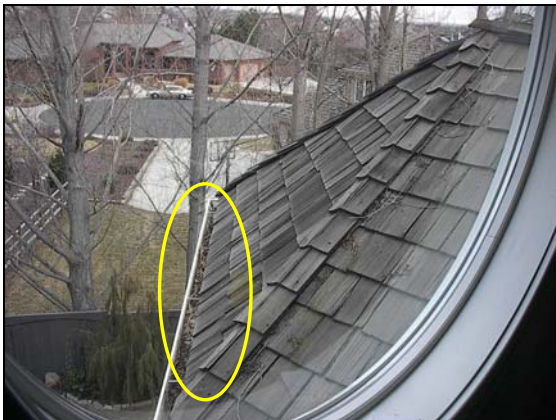
13. Gutters contain debris and require cleaning.

Gutters require cleaning

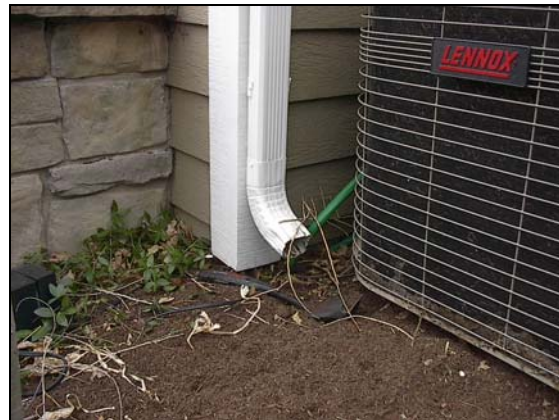
12. All downspouts require extensions or alternative drainage systems to adequately distribute water runoff away from the foundation. In this instance, missing extensions require corrective action.
-

This downspout requires an extension
