BUILDING INSPECTION REPORT

NATIONAL INSPECTION SERVICES

**INSPECTION ADDRESS: 2707 Red Cloud Court
Fort Collins, Colorado**

INSPECTION DATE: July 17, 2009

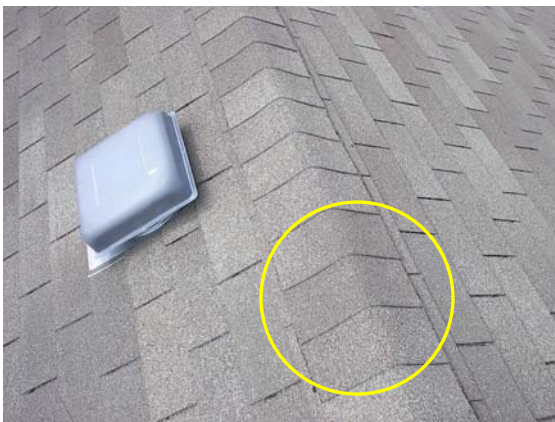
1. Asphalt composition shingles are worn with some cracking and are losing some of their protective coating of mineral granules; however, this roof is in satisfactory condition for its approximated age. Periodic monitoring is recommended.
