BUILDING INSPECTION REPORT

NATIONAL INSPECTION SERVICES

**INSPECTION ADDRESS: 2543 Antelope Road
Fort Collins, Colorado**

INSPECTION DATE: August 7, 2009

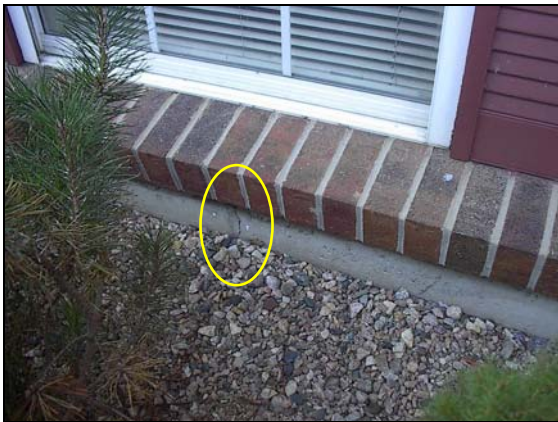
2. Cracking evident in a concrete foundation wall. This crack does not appear to be indicative of a chronic or degenerative condition but should be monitored.

Crack in foundation wall appears inconsequential

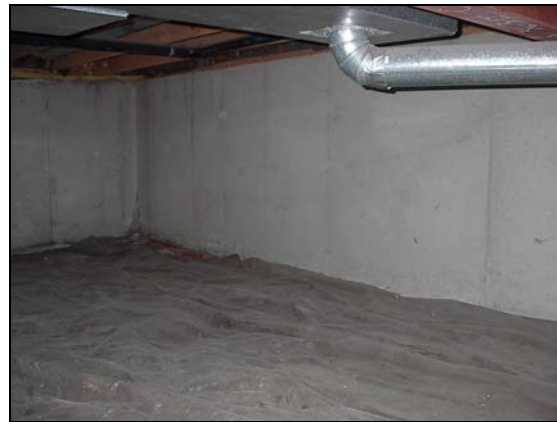
1. Damp soil was found in the crawlspace; however, in this instance, the crawlspace soil is covered by a moisture barrier. It is important to control moisture migrating out of the soil below a house. Periodic monitoring of the barrier is recommended.

Moisture barrier covers soil

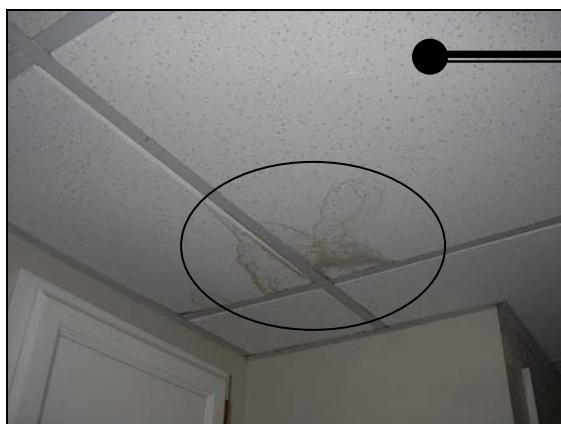
7. Evidence of watermarks on false ceiling (downstairs bathroom) and corresponding water marks on the subfloor or the upstairs bathroom indicate previous water penetration not active at time of inspection; albeit a small water leak in the upstairs bathroom (see comments in Remark #6). Monitoring is recommended.

Evidence of previous leak on lower bath ceiling

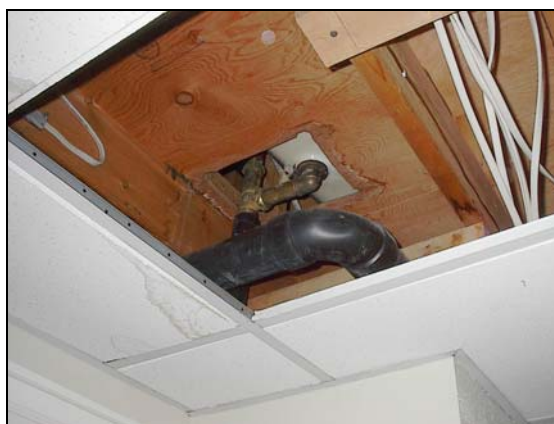
Further investigation revealed dry subfloor

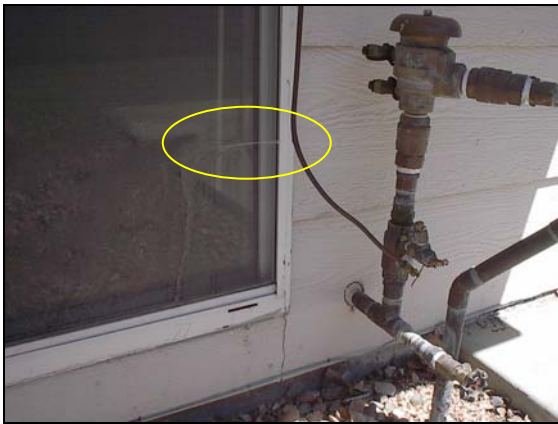
8. The evaporative cooler did not operate as intended; apparently due to a number of breaks in the exterior water supply line, which requires replacement.

Break in water supply line for A/C unit

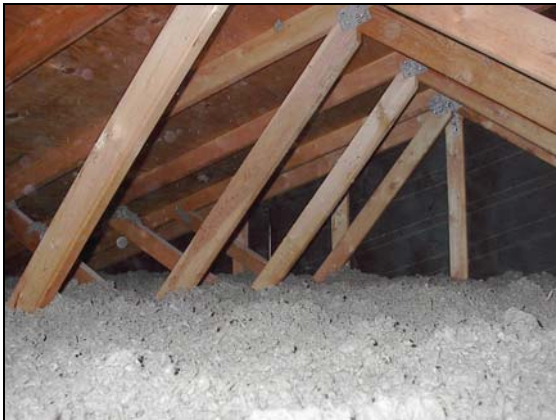
Adequate levels for insulation

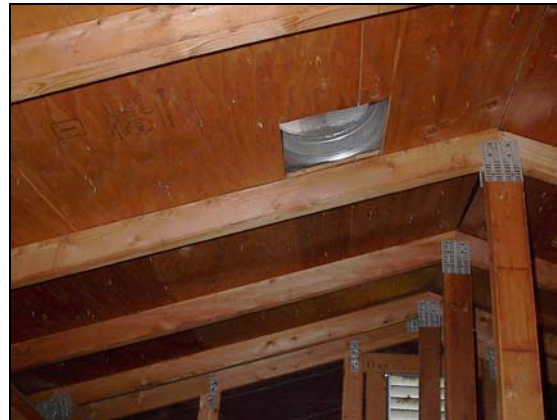
No evidence of water penetration

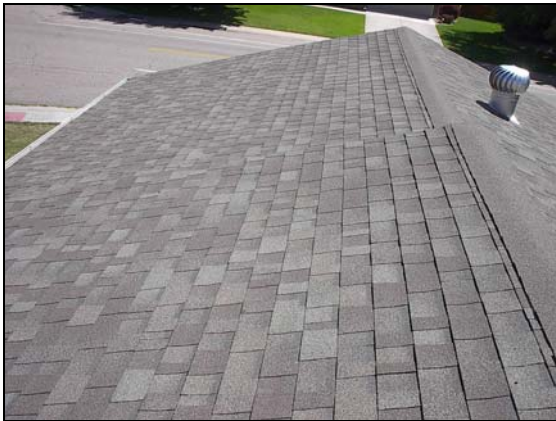
Newer roof is in satisfactory condition
