BUILDING INSPECTION REPORT

NATIONAL INSPECTION SERVICES

**INSPECTION ADDRESS: 380 Aurora Way
Fort Collins, Colorado**

INSPECTION DATE: December 29, 2009

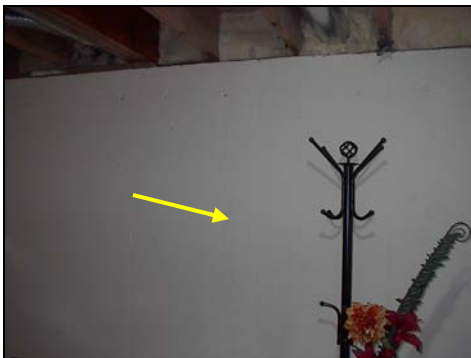
1. Cracking evident in the concrete foundation walls and slab floor. These cracks do not appear to be indicative of a chronic or degenerative condition but should be treated as suspect and require monitoring.

Cracking evident in concrete foundation walls

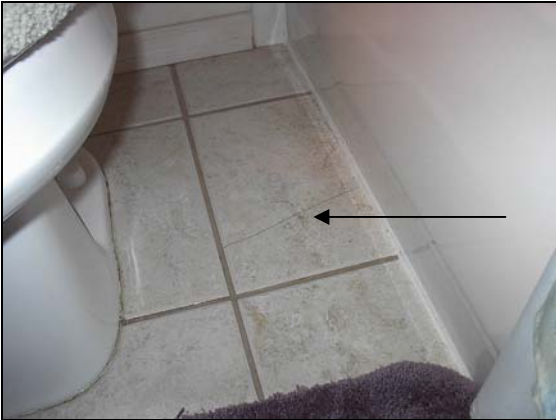
6. Tile floor in Bath 3 is cracked, which requires repair or replacement.
-

Cracked tile floor in Bath 3

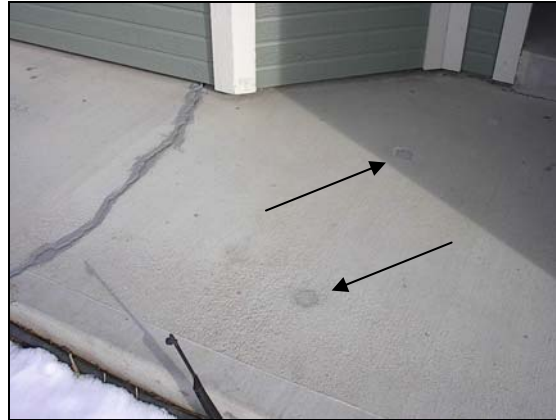
10. Previous exterior flatwork has apparently been addressed through a process commonly referred to as “mud jacking.” Because mud jacking is not necessarily a permanent solution, you should consider any displacement that employs mud jacking and/or sealed cracks that employ acrylic cement, or comparable sealant, as temporary solutions. These areas may be ongoing maintenance issues. The front porch and front sidewalk require monitoring.

Evidence of mud-jacking repair

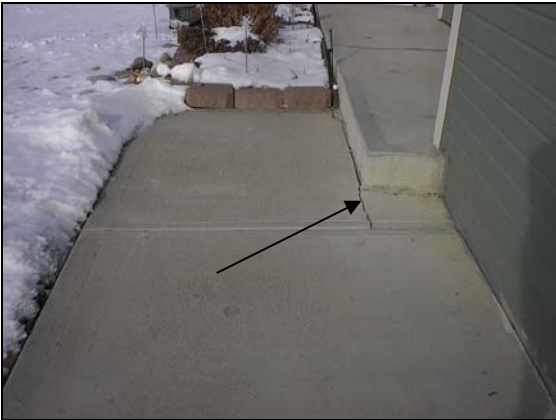
9. Exterior flatwork distress is evident. Driveway, front walkway, and front step display displacement. Driveway and front walkway display cracking. Both cracks and displacement may be the result of swelling soil heaving or, alternatively, localized settling due to improper compaction of backfill. The driveway control joints should be caulked to prevent access for water that accelerates the rate of heaving or settlement damage. See related comments in Remark #10.

Cracking with displacement of front walkway

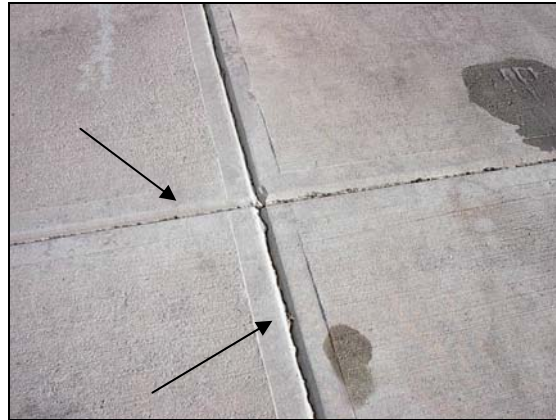
Displacement evident in driveway control joints

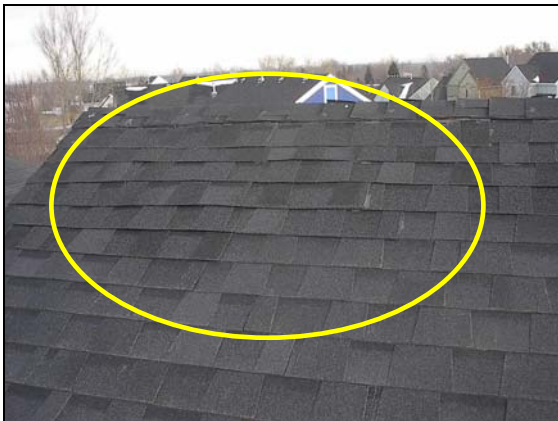
14. Repair and/or replacement to a section of the westernmost south face of the roof cover below the ridge was evident but appears to be adequate. Monitoring is recommended.

Section of roof cover that apparently was replaced
