BUILDING INSPECTION REPORT

NATIONAL INSPECTION SERVICES

**INSPECTION ADDRESS: 8605 W. 18th Street Road
Greeley, Colorado**

INSPECTION DATE: January 7, 2010

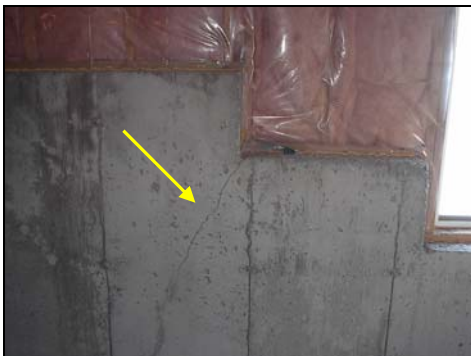
2. Cracking evident in the concrete foundation walls and slab floor. These cracks do not appear to be indicative of a chronic or degenerative condition but should be treated as suspect and require monitoring.

Crack in foundation's west wall

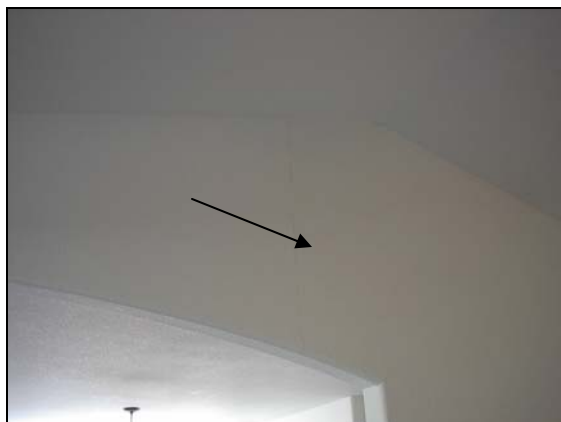
5. The living room wall and ceilings in the living room, hallway outside the laundry room, and the garage all display some cracking, which appear to be inconsequential and do not appear to be chronic or degenerative conditions but should be monitored.

Crack in living room wall

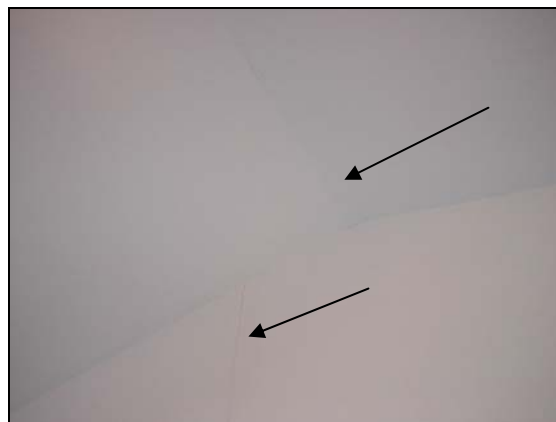
Cracks in living room ceiling and wall

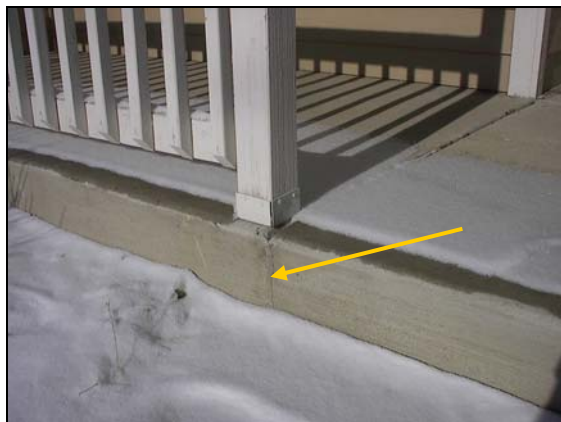
7. The cracking of the front porch may be the result of swelling soil heaving or, alternatively, localized settling due to improper compaction of backfill. This condition should be monitored

Crack of front porch

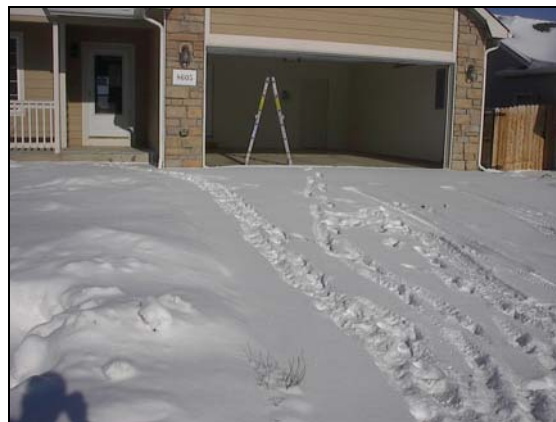
8. Driveway and front walkway were completely snow covered at time of inspection. Consequently, representation about the condition of these exterior concrete components cannot be made since they were either concealed or otherwise inaccessible during the inspection.

Snow covered driveway and walkway

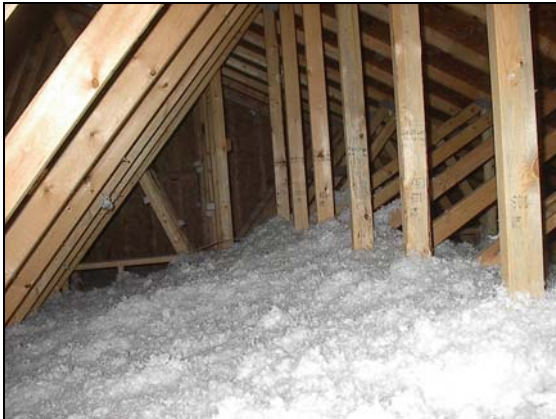
Adequate levels of insulation
