BUILDING INSPECTION REPORT

**INSPECTION ADDRESS: 411 Garfield Street
Fort Collins, Colorado**

INSPECTION DATE: January 11, 2010

Structure Type:	Attached residence, 1-story Over/Under Duplex (Main level unit) and (Upper level unit)
Approximate Year Built:	1910 (Remodel: 1991)
Foundation Type:	Cellar (unfinished) with partial crawlspace

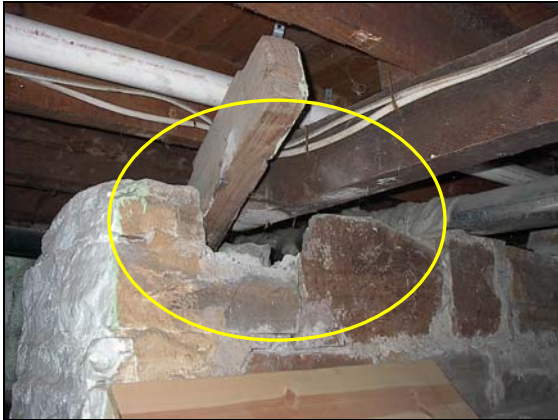
1. Alteration to a load bearing stacked stone wall is evident. Beam support in this area may not conform to design expectations and may be deficient in performance, and it may not be deficient. (See related comments in Remarks #2 and #3.)

Altered support under main carrying beam

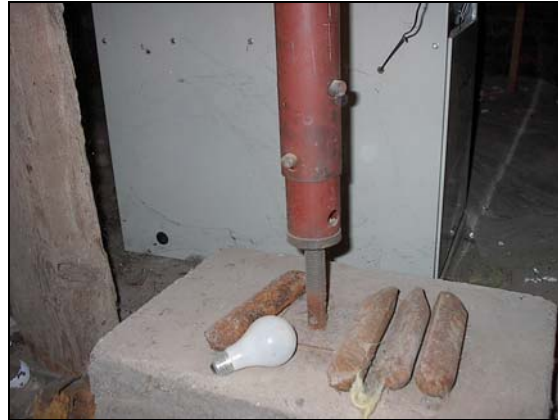
Supporting pins of telescoping column

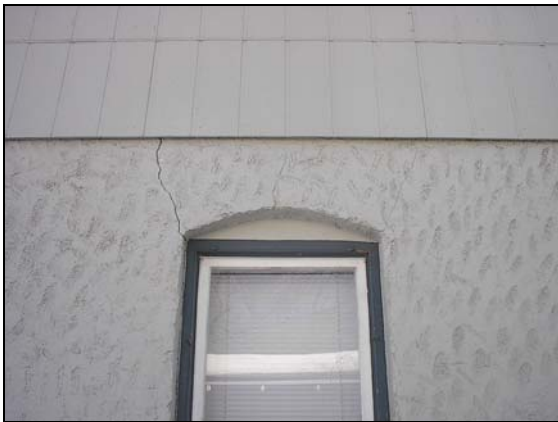
3. Cracks in exterior walls, cladding and foundation, with possible differential movement in the foundation, may not conform to design expectations and may be deficient in performance. In this instance, the orientation, width, location, and/or length of these cracks are suspect. Because structural failure may be characterized as the unacceptable difference between intended and actual structural performance, further structural evaluation by a structural engineer is advised.

Apparent consequential cracking

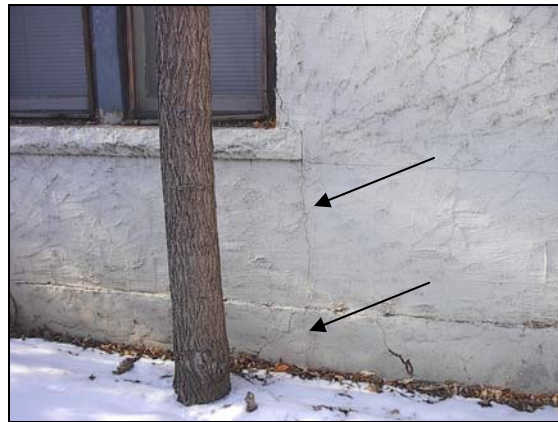
Cracking appears to transition from the foundation

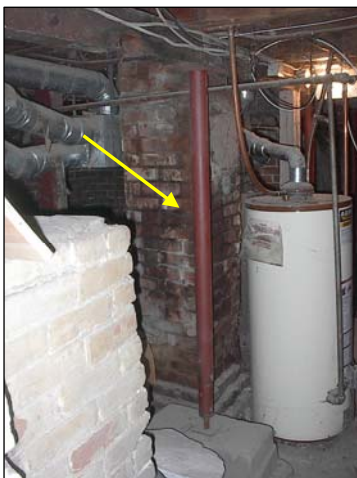
Telescoping (temporary) column

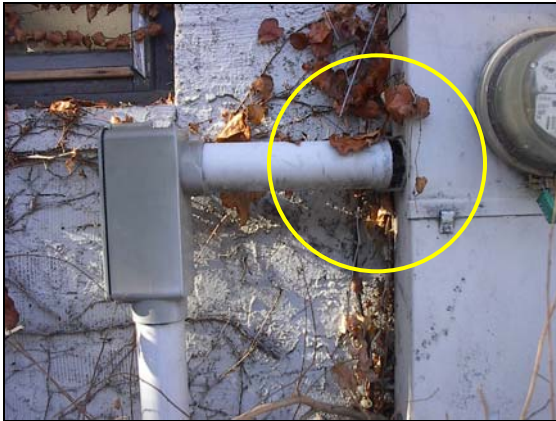
7. Conduit housing for the service lateral (i.e., underground wires running from the utility wires in the street to the home) is damaged and has become dislodged from the service box, exposing the service wires. Exposed wires are susceptible to mechanical damage. The implications, beyond damaged wire, are service interruption, shock hazard and water getting into the electrical system. This condition requires repair. The electrical company or utility usually installs the service drop and may be responsible for maintaining these wires.

Damaged and displaced conduit service lateral housing

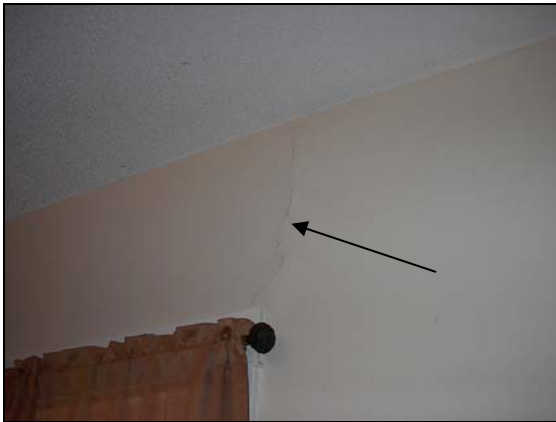
12. Wall in Bedroom 1 (main level) displays cracking, which appears to be consequential (see related comments in Remark #3).
-

Cracking in Bedroom 1 (main level)

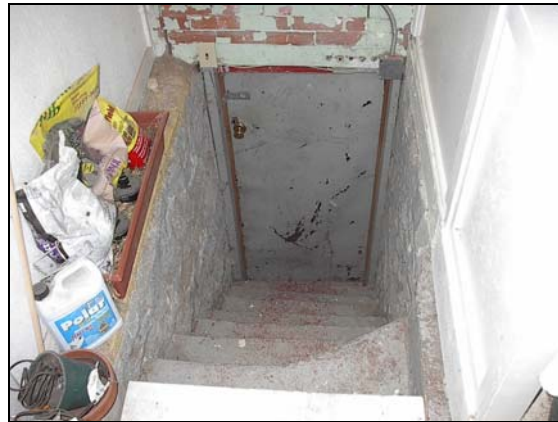
15. All stairs that are more than 24-inches high or that are three risers high require handrails. Missing handrails create a safety hazard. To that regard, the stairs to the cellar require handrails.

Stairway requires handrail

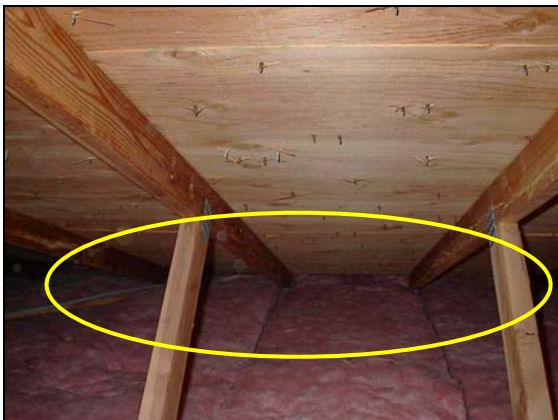
23. Improperly vented attics contribute to shorten life of some roofing and cladding materials due to high attic temperatures and can trap humidity that penetrates the attic or siding from within the house. This condition can also cause structural damage, roof shingles to buckle, insulation to lose its effectiveness and create an environment that is conducive to fungus-like substances. In this instance, baffles that maintain an air space between the insulation and the underside of the roof sheathing are missing and/or insulation is preventing proper venting. Adjustments are recommended.

Insulation is preventing proper venting

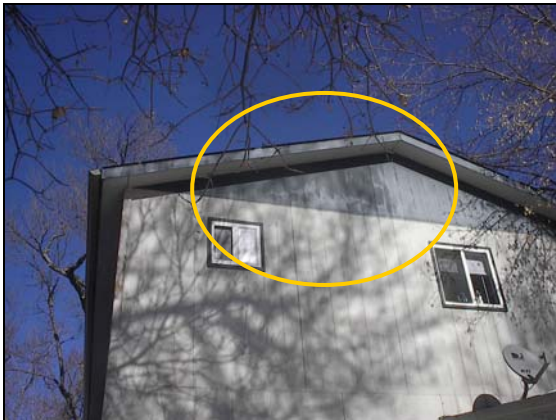
Discoloration of siding
