# BUILDING INSPECTION REPORT

**NATIONAL INSPECTION SERVICES**

**INSPECTION ADDRESS: 2249 Suffolk Street  
Fort Collins, Colorado**

**INSPECTION DATE: January 20, 2010**

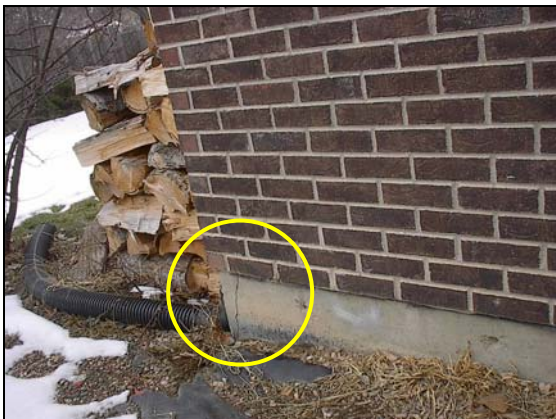
1. Cracking evident in the concrete foundation walls and slab floor. These cracks do not appear to be indicative of a chronic or degenerative condition but should be monitored.

**Inconsequential crack in foundation wall**

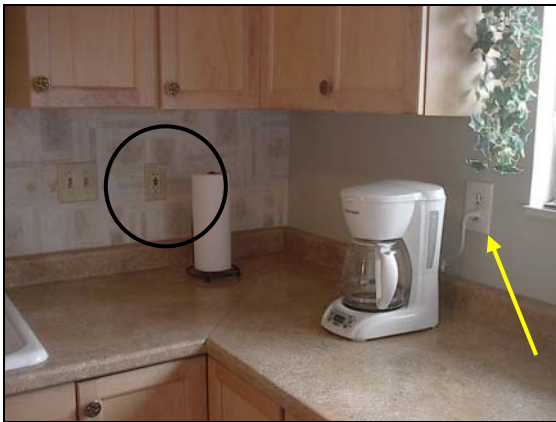
3. I recommend GFCI (ground fault circuit interrupter) protection for receptacles located in bathrooms, garages, kitchens, crawlspaces, and unfinished basements; and in certain locations such as near outdoor spas or hot tubs.
-

Protected outlet (circle) Unprotected (arrow)

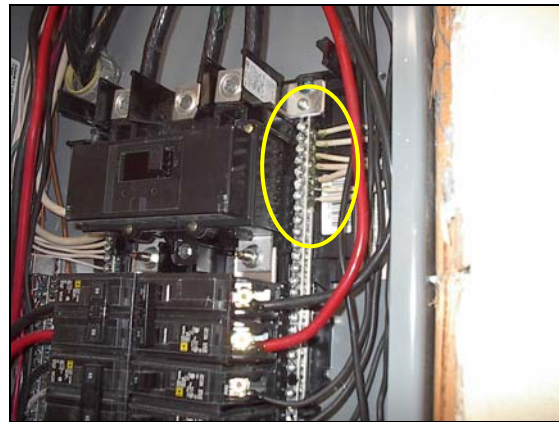
5. In many jurisdictions, stranded aluminum wiring is commonly used for service entrance conductors and for larger appliance wires. However, solid aluminum conductors are problematic because they expand and contract more dramatically than copper and tend to loosen, which creates a fire hazard. In this instance, solid aluminum distribution wiring was evident. Because circuits that use single solid aluminum wiring are considered a significantly higher fire risk than copper wired circuits, I recommend a detailed inspection by a qualified *master* electrician and adjustments pursuant to this advised evaluation. Only a qualified electrician who *specializes* in repairing aluminum wiring\* should perform evaluations and/or repair.

Solid aluminum wiring evident

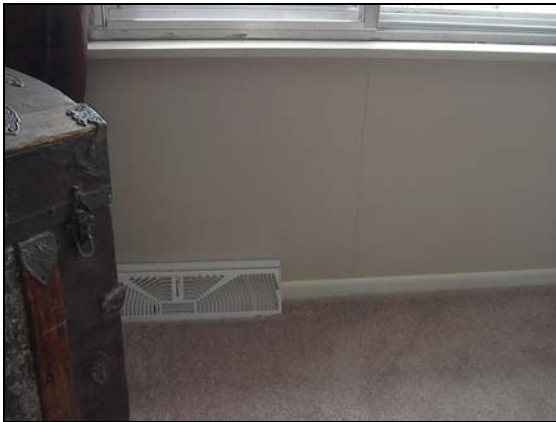
11. Wall in living room and ceiling between living room and dining room display cracking, which appear to be inconsequential and do not appear to be chronic or degenerative conditions.

**Crack in living room wall**

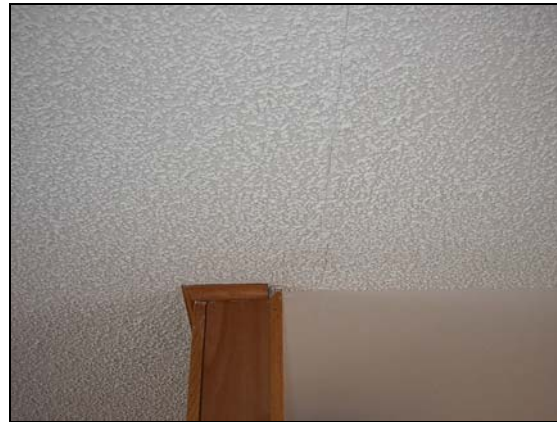
**Crack in living room/dining room ceiling**

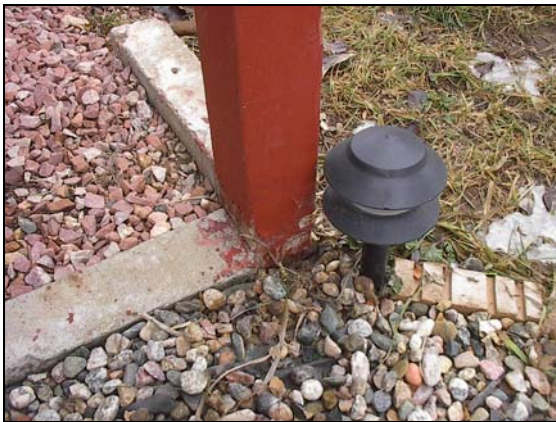
13. Wood deck support posts extend below grade or are otherwise in direct contact with the soil. Wood in contact with soil or below grade is problematic in that they historically do not experience a long life, particularly as a structural member. As a result, there are several design challenges with respect to wood piers, such as rot, termites and improper support.

These wood posts are intended to support the deck and are load bearing. This structure would certainly enjoy a longer life and more utility if its supports were not below grade. Adjustments are recommended. With posts below grade, this deck is compromised.

**Wood support post (deck) in contact with soil**

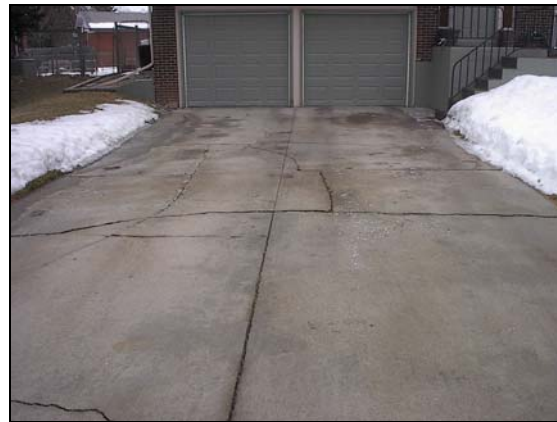
14. Driveway displays cracking with displacement. These cracks may be the result of swelling soil heaving or, alternatively, localized settling due to improper compaction of backfill. These cracks should be caulked to prevent access for water that accelerates the rate of heaving or settlement damage.

**Cracking of driveway**

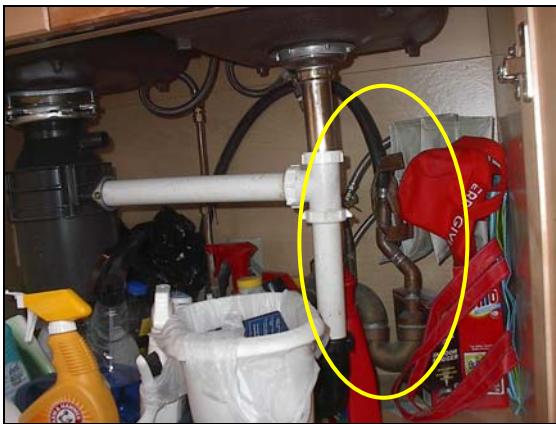
15. In many municipalities, the drain connection from a dishwasher has to be made using an appropriate air gap to prevent backflow; however, different jurisdictions will have their own rules and codes will change over time. In this instance, the drain connection is suspect. While this current configuration may be tolerable; I recommend abandoning this arrangement and installing an air gap fitting or an acceptable alternative connection to prevent contamination in the event that waste backs up through the dishwasher drain hose.

Drain connection for dishwasher

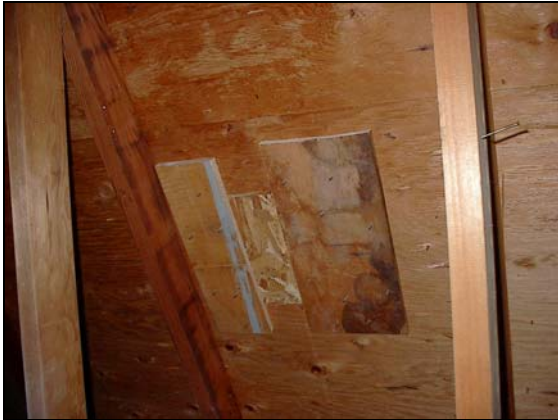
**Repair to sheathing**

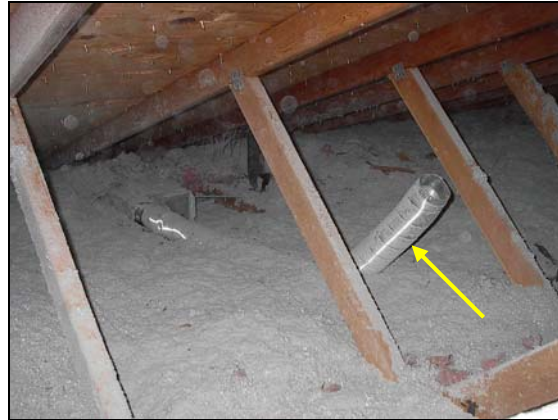
23. Installation of an extension is recommended for the Bath 1 exhaust fan. Currently, this exhaust fan appliance terminates inside the attic, resulting in a potential for structural damage caused by moisture. This assembly also creates a potential for mold colonization, although no mold-like substances were observed. I recommend installing a flexible duct so that moisture created from normal bathroom use is properly vented to the exterior.

**Exhaust duct terminates in attic**

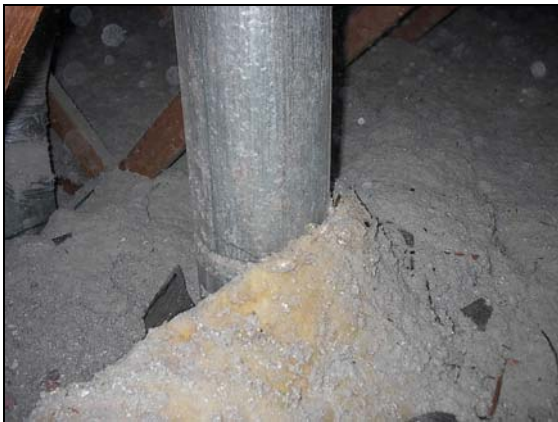
24. There is inadequate clearance of the water heater vent from combustible materials, which is considered a fire hazard. Many authorities consider fiberglass batts (because of its paper surfacing) and cellulose insulation combustible. In this instance, fiberglass batts and cellulose insulation were in direct contact with the vent. Typically a one-inch clearance from B-vents is required; therefore, an adjustment is recommended or appropriate retaining well installed.

**Paper backed batt lying against chimney vent**

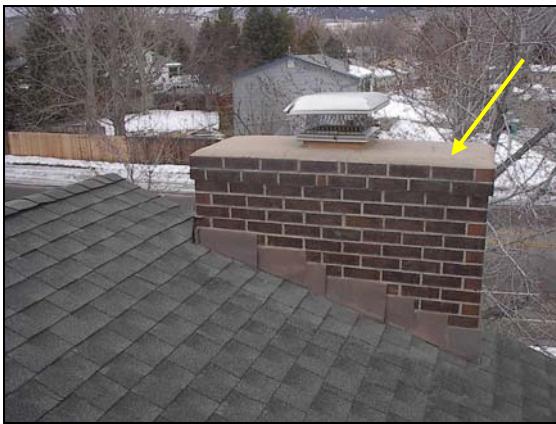
26. Mortar cap displays cracking, which requires repair/sealing. The implications of cracking mortar caps are water leakage into the masonry components and deterioration of the top part of the chimney or structural components below.

Mortar cap requires caulking
