BUILDING INSPECTION REPORT

NATIONAL INSPECTION SERVICES

**INSPECTION ADDRESS: 820 West County Road 74
Wellington, Colorado**

INSPECTION DATE: January 20, 2010

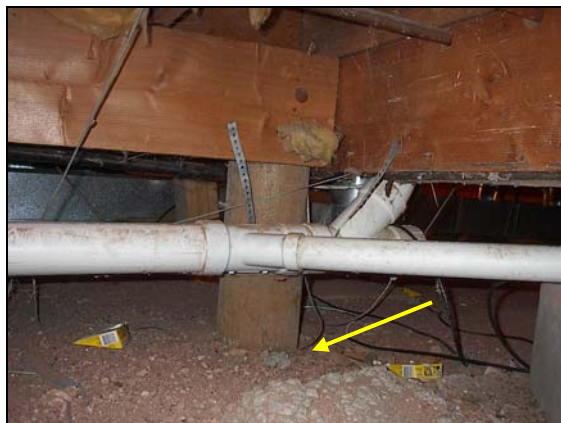
3. Wood support posts extend below grade or are otherwise in direct contact with the soil. Wood in contact with soil or below grade is problematic in that they historically do not experience a long life, particularly as a structural member. As a result, there are several design challenges with respect to wood piers, such as rot, termites and improper support.

These wood posts are intended to support the deck and are load bearing. This structure would certainly enjoy a longer life and more utility if its supports were not below grade. .

Wood support post in contact with soil

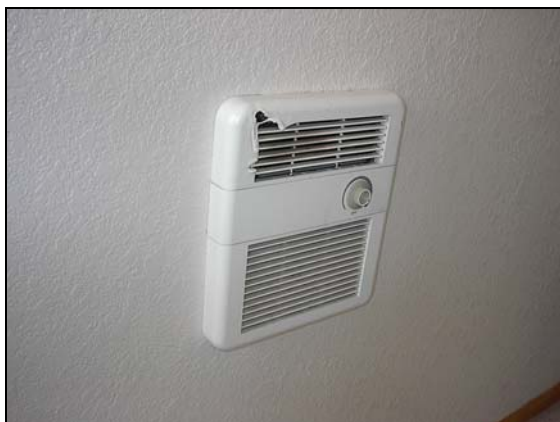
6. Damaged heater cover in Bath 1 may indicate an issue with its electric wall heater, and it may not. This heater requires further evaluation. Furthermore, airflow into and out of electric heaters should not be obstructed. Obstructions may cause the unit to overheat. In this instance, a towel rack in Bath 2 is an installation issue that is considered a fire safety hazard. Manufacturer's recommendations can be checked for specific clearance requirements on different types of heaters.

Damaged cover in Bath 1

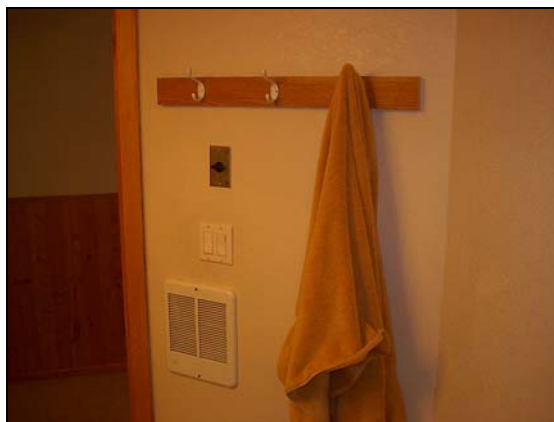
Towel rack above electric wall heater in Bath 2

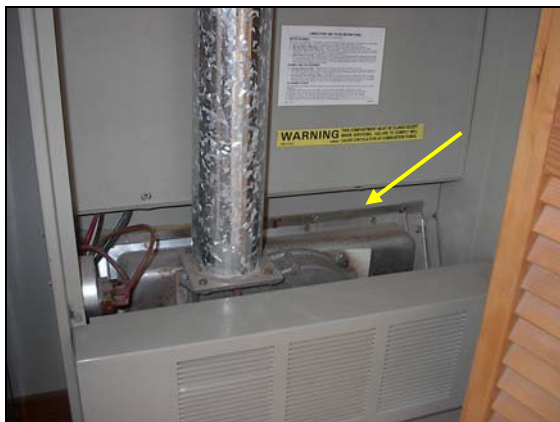
5. Although beyond ASHI Standards but as a benefit to the client, the furnace was tested using a combustible gas detection instrument, i.e., a device that senses hydrocarbons, spillage of combustion products and raw gas leaks. While this device can uncover combustion products in the ambient air, it cannot measure the concentration of the gas. In this instance, a positive result was detected near the furnace's induced draft assembly, which may reveal a safety concern or it may not. Even though this finding may be indicative of a non-threatening condition, I recommend a system evaluation be performed by a qualified contractor to ensure a safely operating and efficient furnace.

Spillage at induced draft assembly

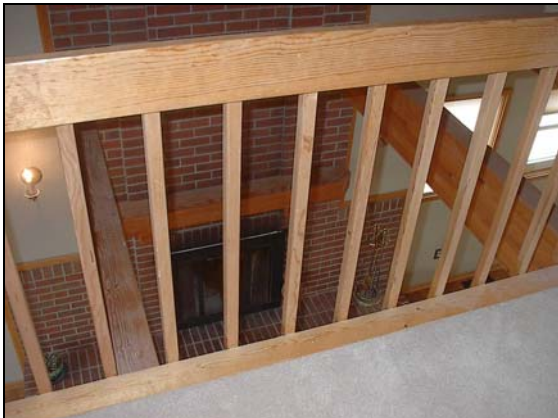
15. Guardrails must be constructed so that people cannot fall through. Openings in railing balusters greater than 4" create severe hazards for small children. In this instance, the spindles of the balcony above the living room are design issues from a safety standpoint with respect to spindle spacing. A protective barrier or other adjustment is recommended when small children are present.

Spacing of guardrail at balcony above living room

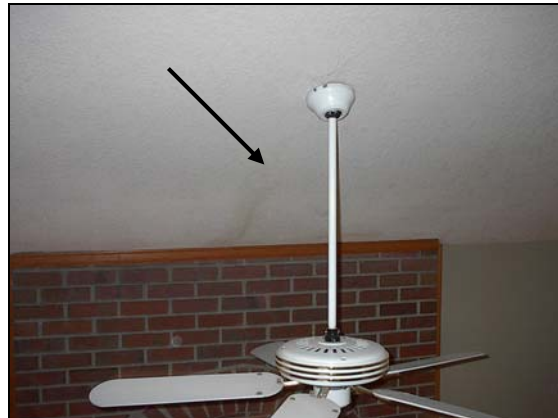
11. Ceiling in living room displays cracking, which appears to be inconsequential and does not appear to be a chronic or degenerative condition.

Crack in living room ceiling

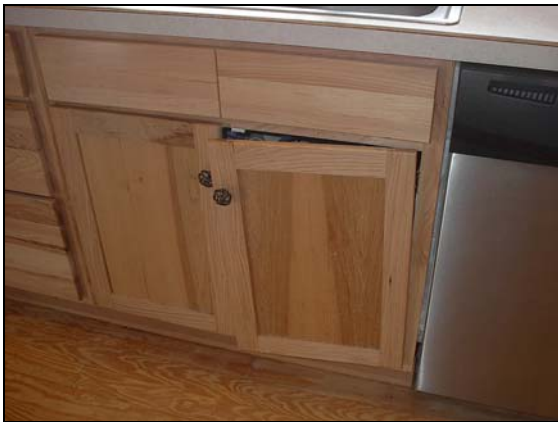
Displaced kitchen cabinet door

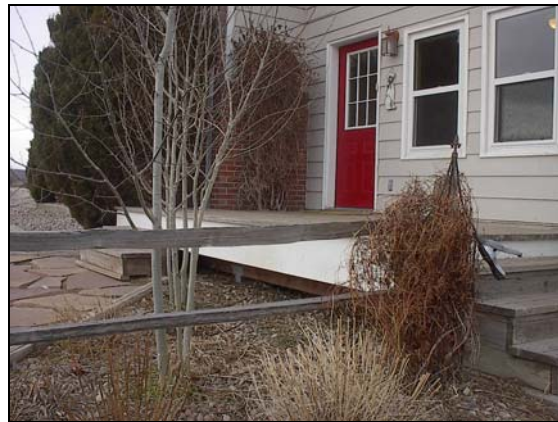
14. Guardrails keep people from falling off open sides of landings, decks, and balconies. Guards are required if the floor of the deck, porch or balcony is more than 24" to 30" above grade, depending on jurisdiction. In this instance, the height of the front deck is approximately 26-inches above grade. As different jurisdictions will have their own rules, I recommend the customer confer with the primary authority for the need or requirement of a guardrail.

Height of deck floor is approx. 26-inches above grade

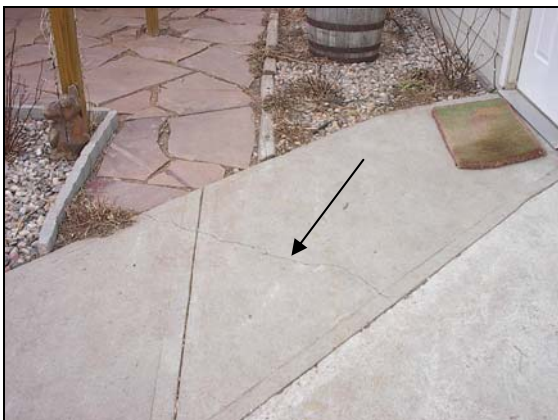
16. Walkway to detached garage displays cracking. These cracks may be the result of swelling soil heaving or, alternatively, localized settling due to improper compaction of backfill. These cracks should be caulked to prevent access for water that accelerates the rate of heaving or settlement damage.

Cracking of walkway

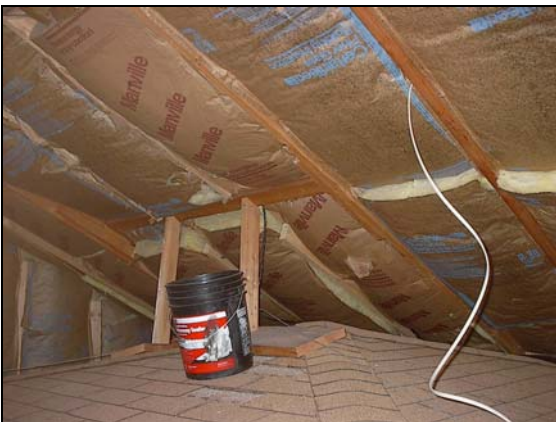
19. Unconventional supports have been attached to a roof of what appears to be the original building and apparently as part of a remodel / addition.

Unconventional supports attached to original roof

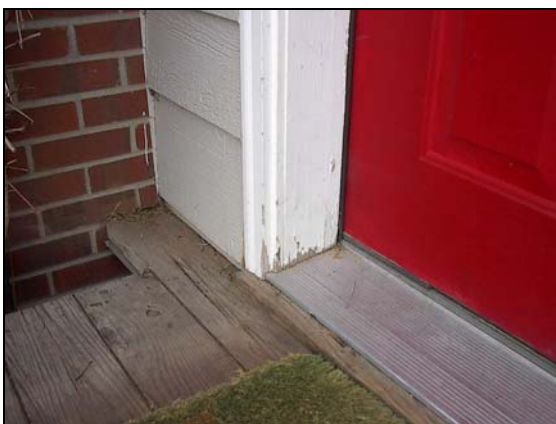
**20.** Peeling and/or worn paint is evident at door and window frames, resulting in exposed wood; which require sanding, priming and re-painting. Also, water damaged trim at the SE corner and near the deck; which requires repair, priming and re-painting.

Peeling and worn paint at door frame

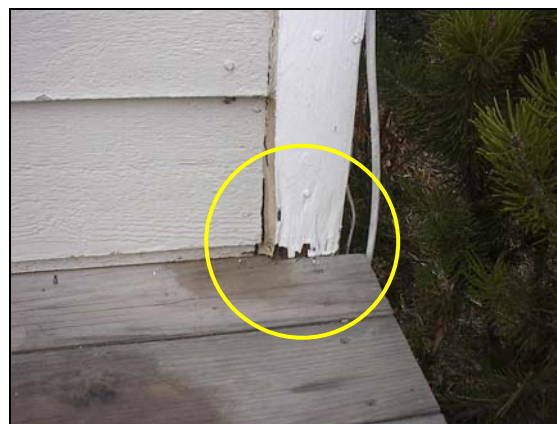
Water damaged wood trim

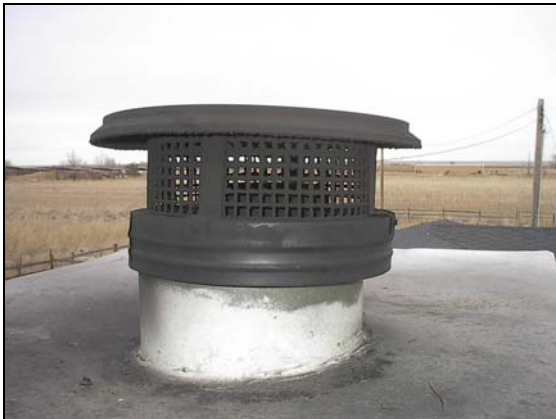
24. Chimney and chimney caps require cleaned by a qualified contractor.

Chimney and chimney caps require cleaning
