# BUILDING INSPECTION REPORT

**NATIONAL INSPECTION SERVICES**

**INSPECTION ADDRESS: 90 Mount Axtell Drive  
Livermore, Colorado**

**INSPECTION DATE: June 7, 2010**

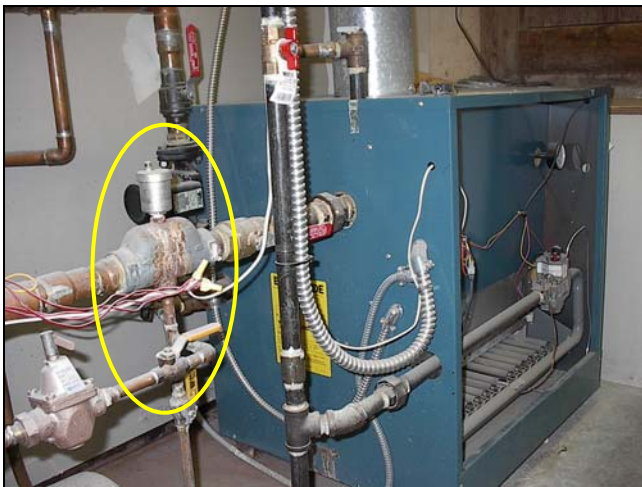
1. Rust was evident at the in-line air vent valve on the distribution side of the system that indicates previous or current leaking not active at the time of the inspection. Because this is an important component of the hot water piping system, normal servicing is recommended including a comprehensive system evaluation by a qualified contractor.

Rust evident at the in-line air vent valve

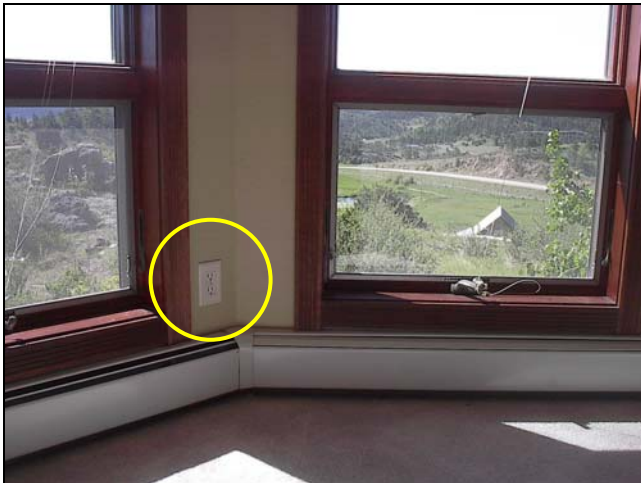
- +** 5. It is no longer considered an acceptable practice to locate outlets above baseboard heaters. Cords plugged into these outlets will tend to drape over the heaters and may overheat, which creates a fire hazard. In this instance, there are a number of outlets that have been located above baseboard heaters when this home was built. Because this report is not intended to be a review of building code compliance and since codes are not usually retroactive; strategy for cure, if any, should be consistent with future expectations.

Electric outlet above baseboard heater

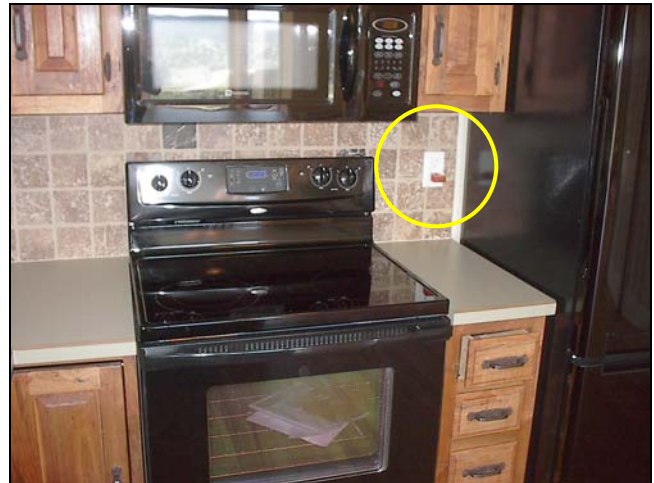
4. A kitchen receptacle, located to the right of the range, tested as not energized. No obvious reason for this condition was determined. Further evaluation of this receptacle and the electrical system by a qualified electrician is recommended.

This outlet was not energized

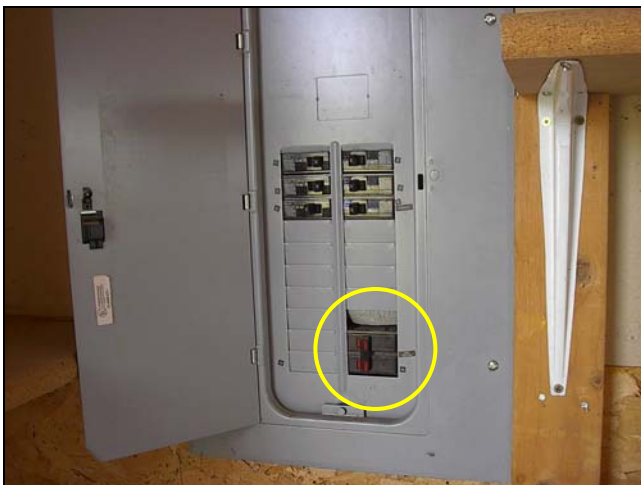
- ✘** 6. The main distribution panel and the sub-panel require accurate and complete labeling of all breakers. This is an important safety issue.
- +** 7. The sub-panel has an unprotected opening. An open breaker slot is a safety issue, should a person place a finger in this gap while re-setting a tripped breaker. This opening must be replaced with a cover.

Open slot in main panel

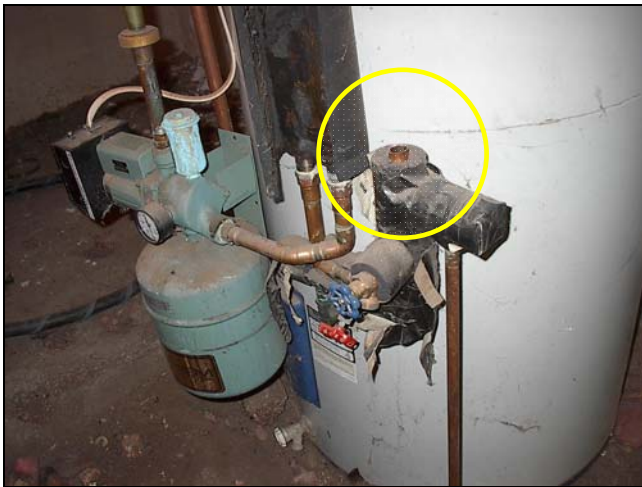
10. Note: An abandoned 112 gallon Bradford White (S/N BJ4986784) solar storage tank was located in the crawl space. This tank appears to hold an indeterminate amount of water. It is recommended that this tank be confirmed abandoned and purged to eliminate the risk of damage from a future leak.

Cut pipe to an apparently abandoned tank

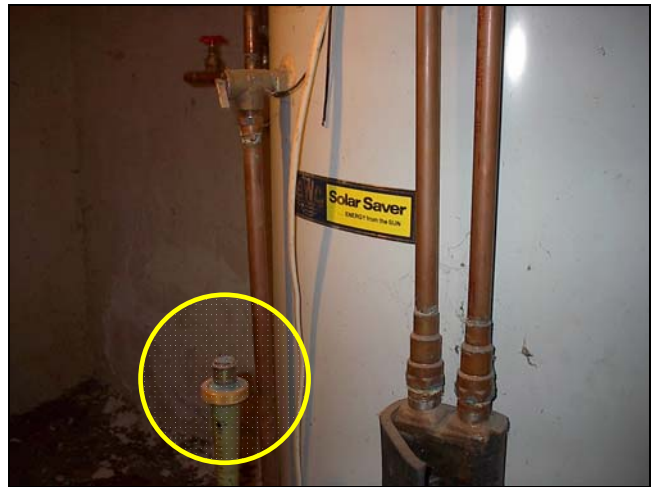
Cut pipe to an apparently abandoned tank

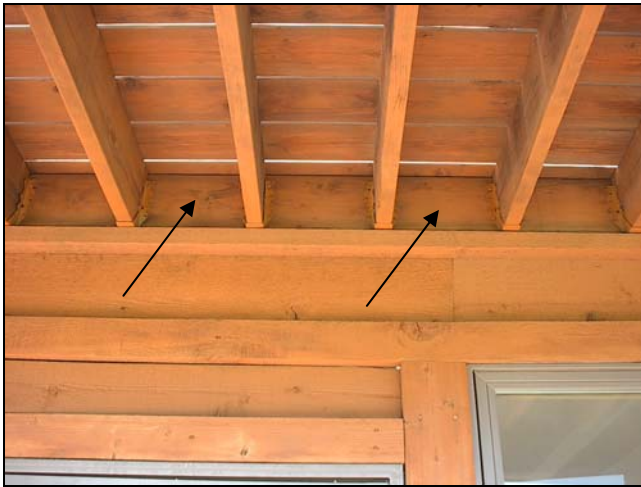
14. Both upper and lower decks may be compromised due to connections that are suspect. In this instance, the ledgerboard fasteners are nails not lag screws. Lag screws are recommended by industry safety protocol. These issues create structural stability concerns that may not conform to design expectations and may be deficient in performance. As a result, there are several challenges with respect to proper support that could result in catastrophic failure. Because the decks' stability may be compromised, I recommend adjustments to strengthen these connections.

**Nailed ledgerboard**

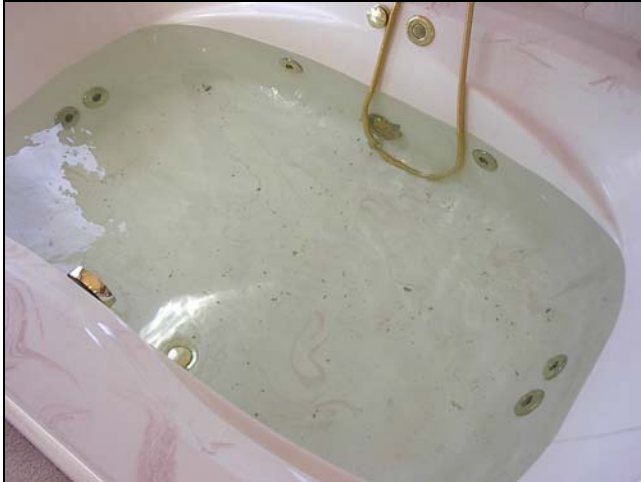
**Debris in jetted tub**

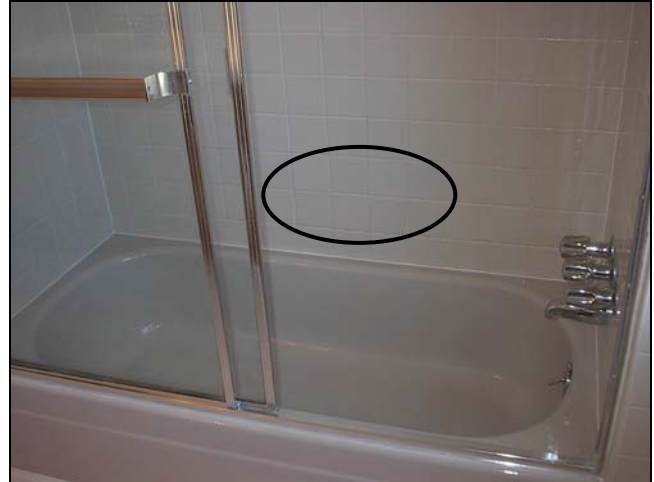
22. Grout in Bath 2 shower is shallow, cracked, absent or not well bonded to the shower tiles in areas, which requires restoration to improve these joints. The implication is that water from the shower may penetrate the bath wall voids. Hidden wall and floor components may possess latent water damage that was not detected during the inspection, and they may not. In this instance, the full extent of the condition of these items cannot be determined from my limited visual inspection. At a minimum, shower wall tiles in Bath 2 require grout restoration.

**Grout restoration needed**

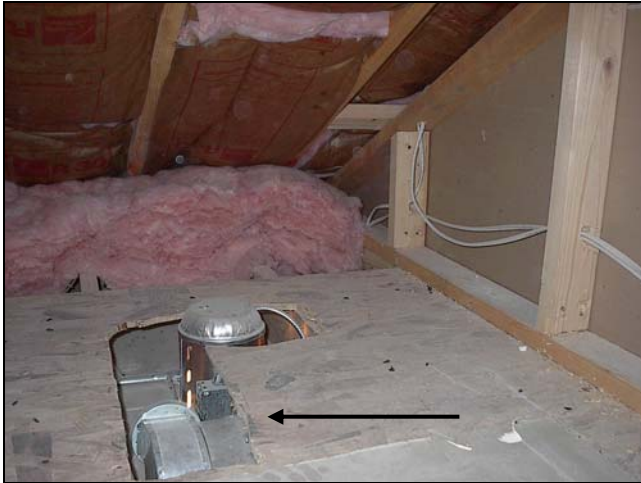
26. It is preferable that bathroom exhaust fans vent to the exterior. Currently, the Bath 1 exhaust fan terminates inside the attic area, resulting in a potential for damage to structural components, insulation or ceilings caused by moisture. Venting to the exterior that will result in preferred discharge of bathroom moisture is recommended.

**Bath 1 exhaust fan terminates in attic**

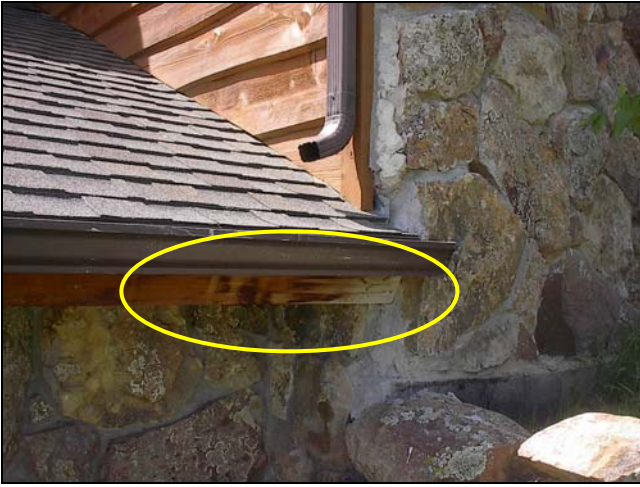
27. Watermarks on a section of north fascia and soffit and at the soffit of the front porch indicate roof drainage issues and roof flashing. See related comments in Remark #28. Further evaluation by a qualified contractor and corrective action is recommended.

**Watermarks on fascia – north**

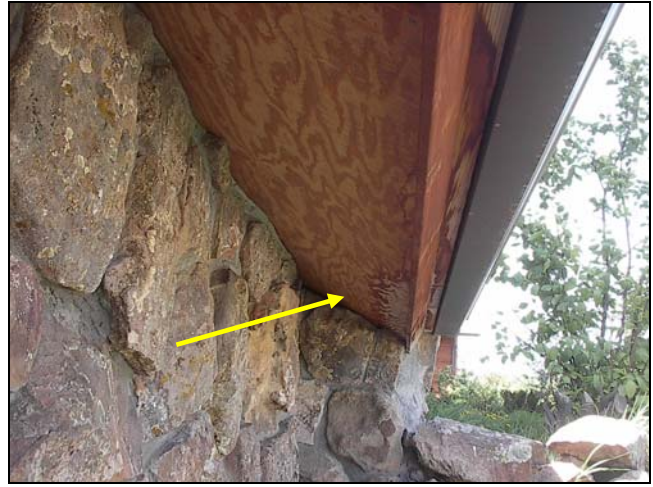
**Watermarks on soffit – north**

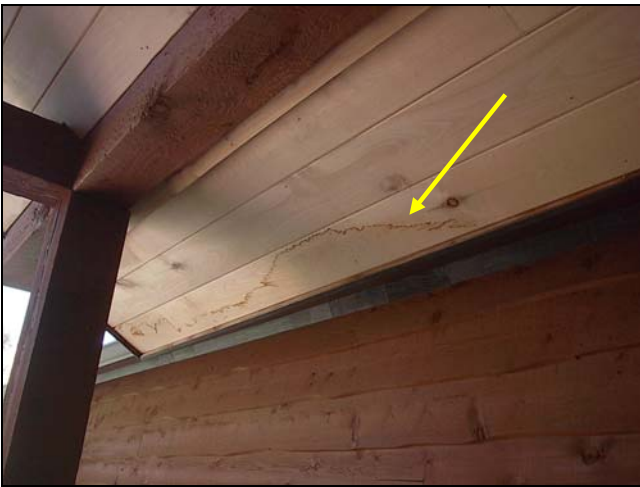
**Watermarks on soffit – front porch**

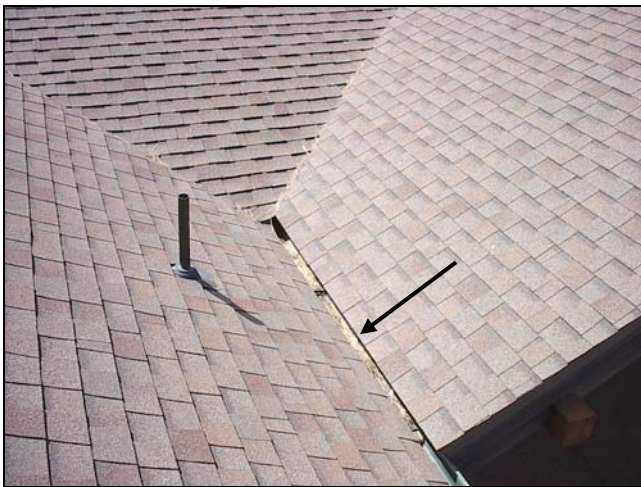
29. Gutter at the front porch contains debris; which may lead to roof drainage backup that results in water penetration of the eaves (see related comments in Remark #27) and requires cleaning.

**Debris in gutter**

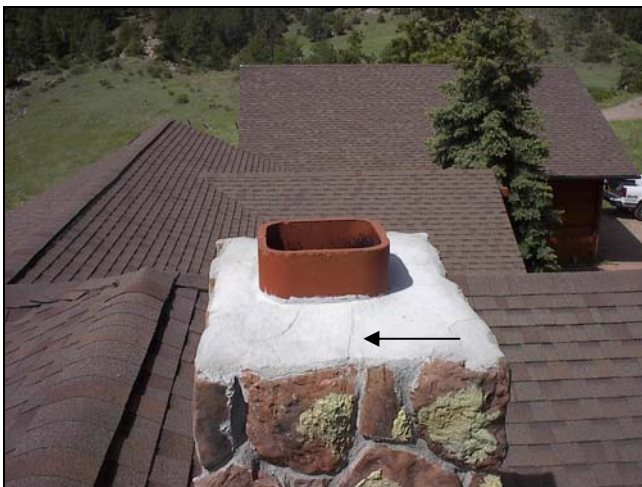
**30.** Mortar cap displays cracking, which requires repair/sealing. The implications of cracking mortar caps are water leakage into the masonry components and deterioration of the top part of the chimney or structural components below.

**31.** Masonry fireplace chimney requires a storm or rain cap with spark arrester consisting of ½ inch or less non-combustible mesh. The implications of absent caps are water leakage into the masonry components and deterioration of the top part of the chimney or structural components below. Also, storm caps keep rain, snow, birds, and animals out of the chimney and prevent downdrafts that allow combustion products, including carbon monoxide, to enter the house air.

**Storm cap needed and cracks in mortar cap (arrow)**

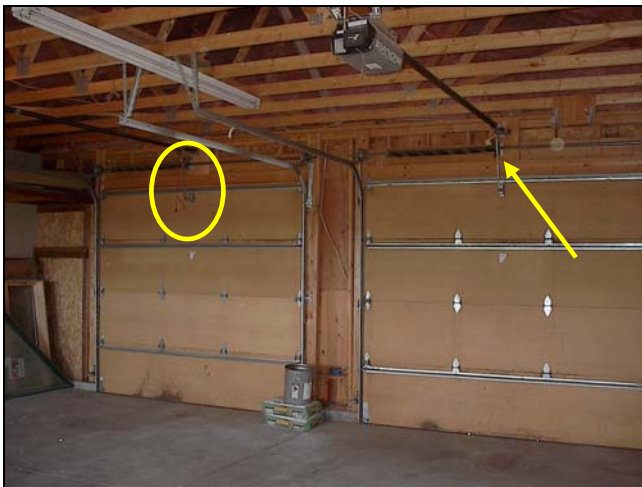
- 33. The manual release handle is meant to manually detach the door from the door opener in an emergency. This handle is required to be red and easily distinguishable. The handle should be easily assessable and no more than six feet (6') above the garage floor. In this instance, the manual release handles for both doors are more than six feet above the garage floor or are absent and require adjustments.

Release handle too high (circle)  
Release handle missing (arrow)
