# BUILDING INSPECTION REPORT

**NATIONAL INSPECTION SERVICES**

**INSPECTION ADDRESS: 1824 Overlook Drive  
Fort Collins, Colorado**

**INSPECTION DATE: June 9, 2010**

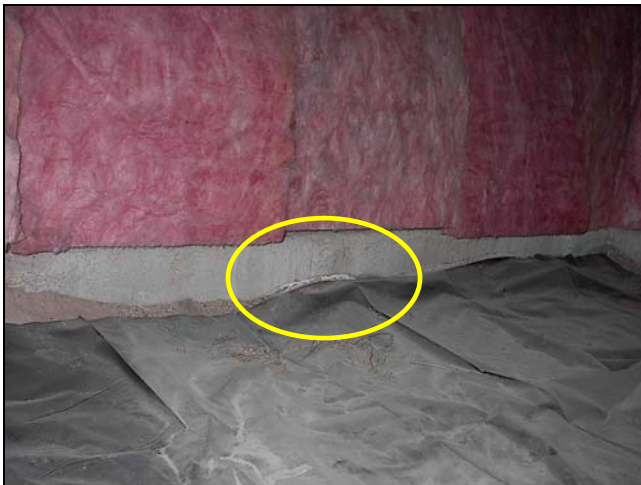
1. Efflorescence was present on foundation walls. Efflorescence is whitish, powdery salt stains that are left on masonry surfaces after moisture evaporates, which indicates previous and/or possible current water penetration or infiltration not active at time of inspection. This condition requires monitoring.

Efflorescence was present on foundation walls

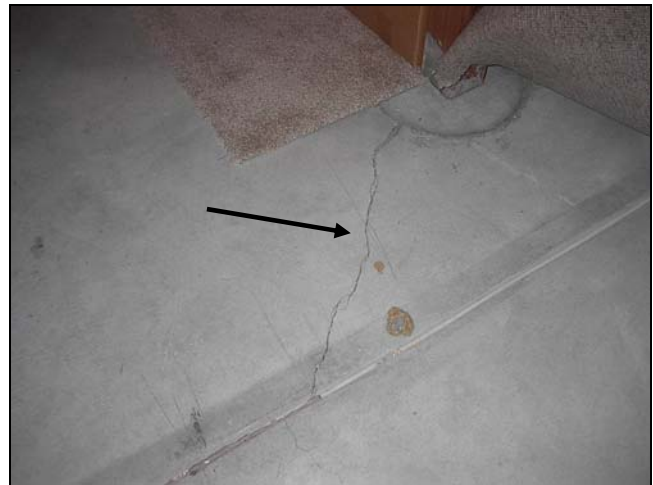
2. Cracking evident in the concrete slab floor. These cracks do not appear to be indicative of a chronic or degenerative condition but should be treated as suspect and require monitoring.

Cracking evident in the concrete slab floor

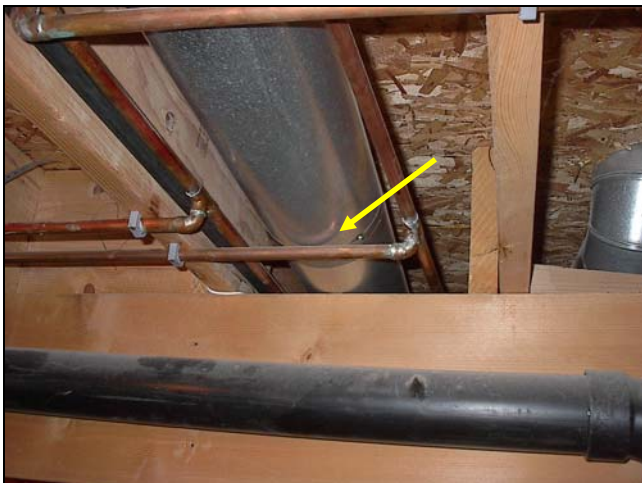
6. Galvanized metal in contact with copper water supply piping can lead to galvanic action between the dissimilar metals. This is characterized by accelerated corrosion at the point of contact and leaking. Separation of these dissimilar metals utilizing a di-electric separator can avoid such problems. Further adjustment by a qualified contractor is recommended.

**Galvanized metal in contact with copper water supply piping**

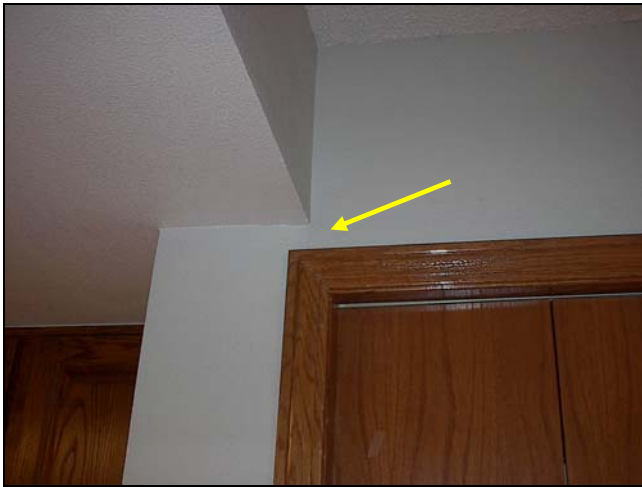
7. Wall in the kitchen displays cracking, which appears to be inconsequential and does not appear to be a chronic or degenerative condition.

**Crack in kitchen wall**

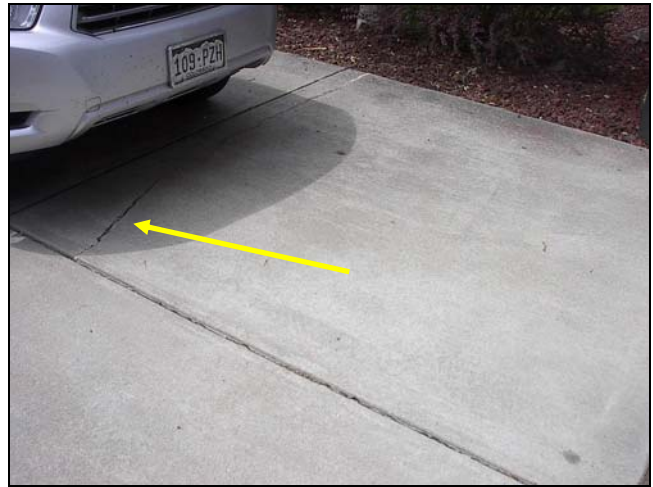
9. Driveway and front walkway display cracking. These cracks may be the result of swelling soil heaving or, alternatively, localized settling due to improper compaction of backfill. These cracks should be caulked to prevent access for water that accelerates the rate of heaving or settlement damage.

**Crack in driveway**

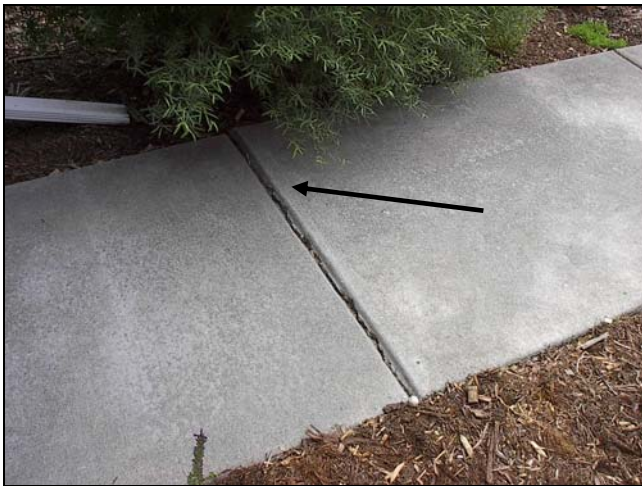
10. Exterior flatwork distress is evident at the front walkway. Vertical displacement of the walkway is an egress issue that creates a possible trip hazard and requires repair or section replacement. This displacement may be the result of swelling soil heaving or, alternatively, localized settling due to improper compaction of backfill, or erosion from roof drainage from nearby downspout.

**Cracking with displacement**

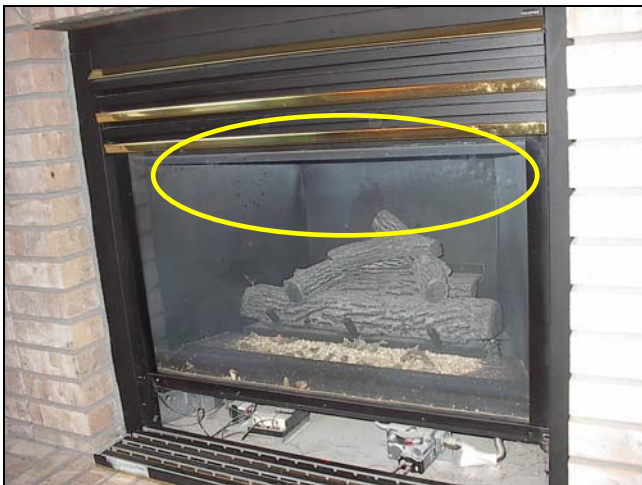
11. Oxidation, i.e. whitish-brown residue evident on inside of the glass, may be indicative of a venting issue or incomplete combustion, which is a potential health safety hazard. This fireplace glass requires cleaning to manufacturer detail and the unit requires further evaluation by a qualified fireplace specialist.

**Oxidation on fireplace glass**

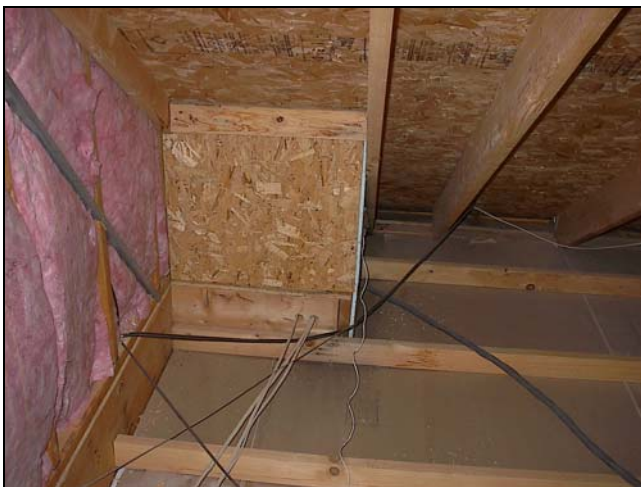
14. Evidence of watermarks on framing members in the garage attic and the garage ceiling indicate previous and/or possible current water penetration not active at time of inspection. Monitor and repair as needed. (Also, see related comments in Remarks #16 and #19.)

**Watermarks on wood members**

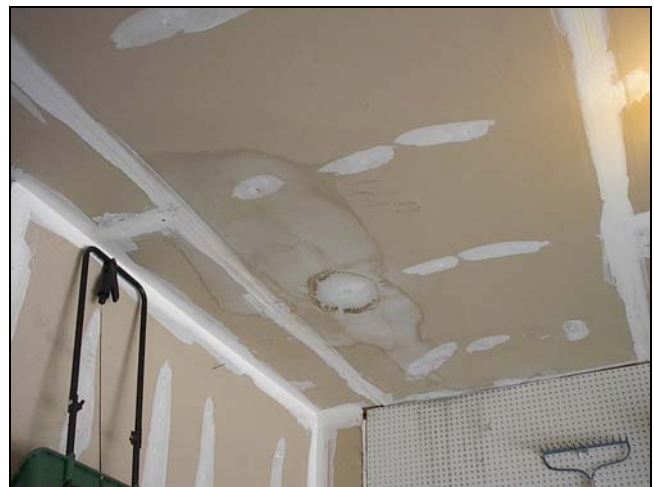
**Watermark on garage ceiling**

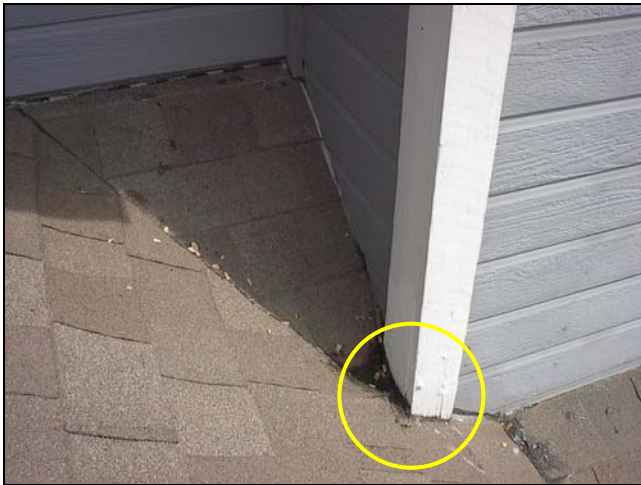
**16.** A section of wood trim at a short valley above the garage displays some water damage from absorbing moisture. The bottom of the trim appears to be damming roof drainage from an adjacent gutter extension; causing water backup and apparent water intrusion (see Remark #14). An adjustment (see related comments in Remark #19) is recommended. Further evaluation from a qualified contractor is needed to determine the best permanent cure.

Wood trim at short valley above garage

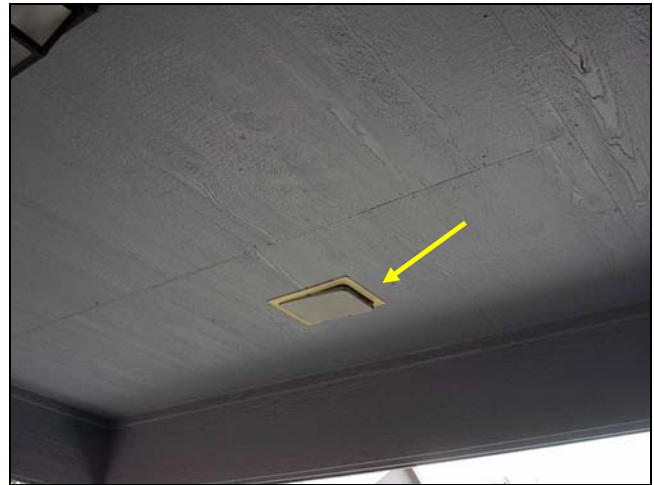
**17.** An exterior speaker cover at the rear porch is dislodged and requires an adjustment or repair.

Speaker cover dislodged

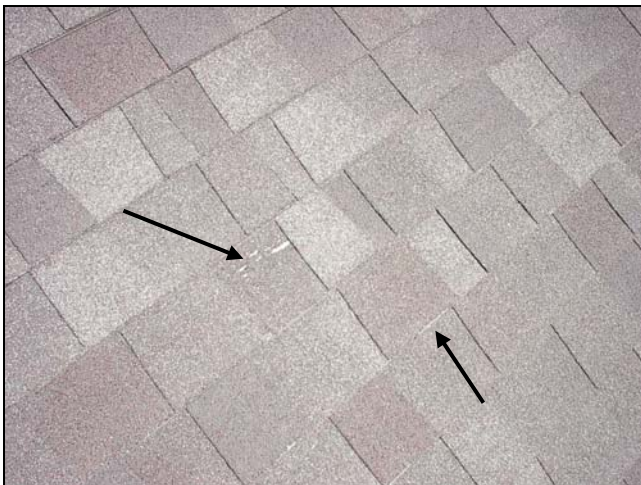
18. Asphalt composition shingles are worn, had some cracking and damage, were losing their protective coating of mineral granules, and otherwise were showing signs of their approximated age. Periodic monitoring with repairs as needed is recommended.

Damage and wear to shingles

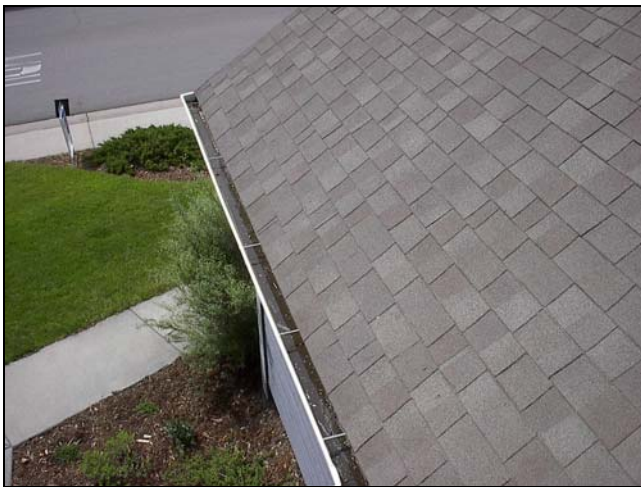
**20.** Standing water is evident in east gutters at the garage. Drainage system requires re-fastening and re-sloping.

**Standing water in east gutter**

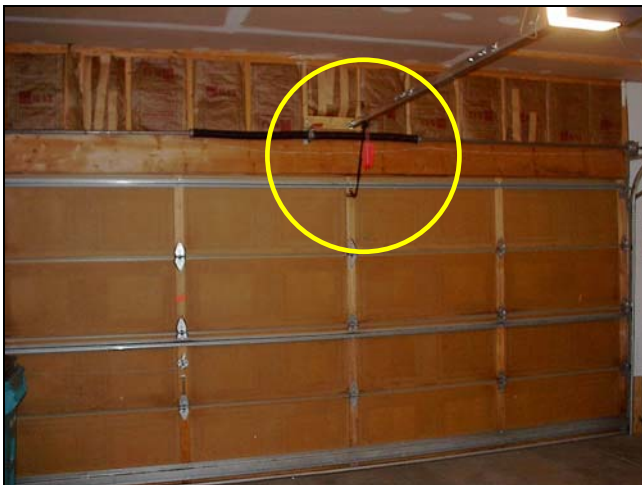
21. The manual release handle is meant to manually detach the door from the door opener in an emergency. This handle is required to be red and easily distinguishable. The handle should be easily assessable and no more than six feet (6') above the garage floor. In this instance, the manual release handle is more than six feet above the garage floor and requires an adjustment.

**Emergency release handle**
