BUILDING INSPECTION REPORT

**INSPECTION ADDRESS: 1814 Rollins Gate Road
Fort Collins, Colorado**

INSPECTION DATE: June 12, 2010

Report number:	N3488
Time started / finished:	9:00 12:00
Present during inspection:	Buyers and Buyers' Realtor
For reference, front of house faces:	South
Ground condition:	Damp
Weather:	Raining with mild temperatures

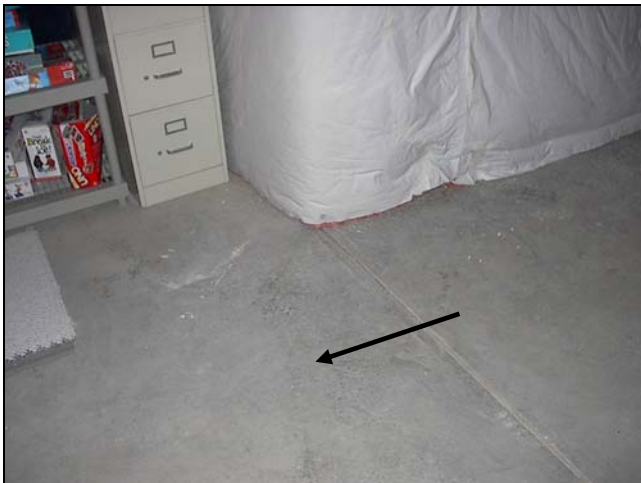
1. Cracking evident in the concrete slab floor. These cracks do not appear to be indicative of a chronic or degenerative condition but require monitoring.

Crack in concrete slab floor

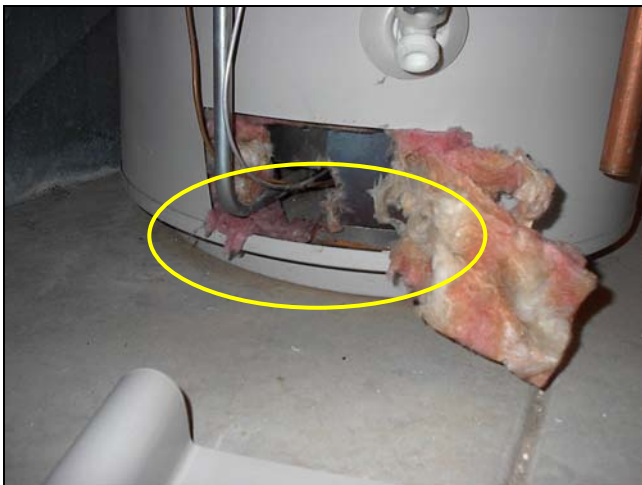
2. The water heater was functional; however, rust was evident, which is problematic in that rusting tanks are prone to leakage. Based on industry standards, water heaters of this approximated age are considered nearing or at the end of their service life. I recommend monitoring for future leaks or proactive replacement.

Rust was evident at water heater

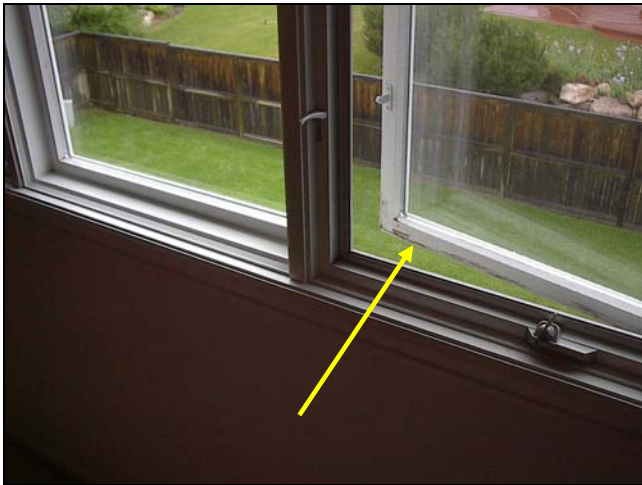
- 5a. Peeling and/or worn paint is evident a number of interior window frames, resulting in exposed wood; which require sanding, priming and re-painting.

Peeling paint on interior window frame

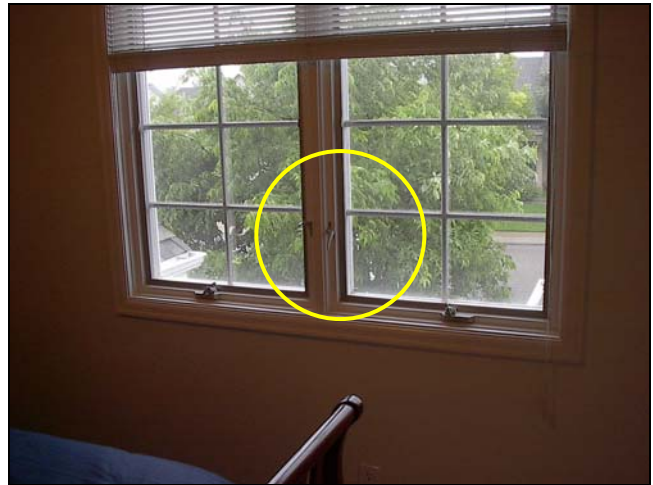
- 5b. Some window latches (i.e., Bedroom 4 and the living room) did not operate as intended, which require an adjustment or repair.

Latch in Bedroom 4 did not operate as intended

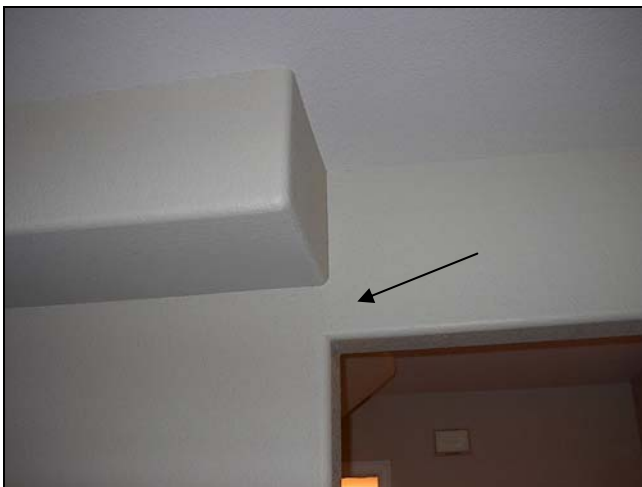
4. Wall in family room displays cracking, which appears to be inconsequential and does not appear to be a chronic or degenerative condition.

Crack in family room wall

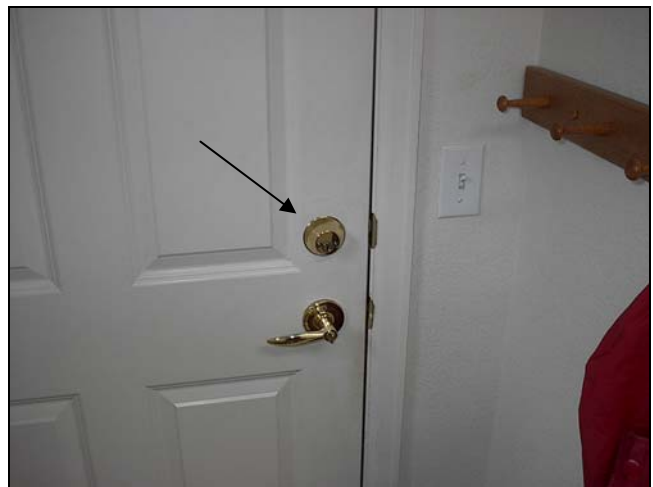
7. Double-keyed deadbolts are egress safety obstacles. During an emergency, a safety hazard would occur if the key was not available. Alternatively, consideration should be given to replacing the current double-keyed deadbolt at the laundry room door leading to the garage with a thumb-latch style deadbolt, which doesn't require a key to unlock from the inside, to improve emergency egress.

Double keyed deadbolt

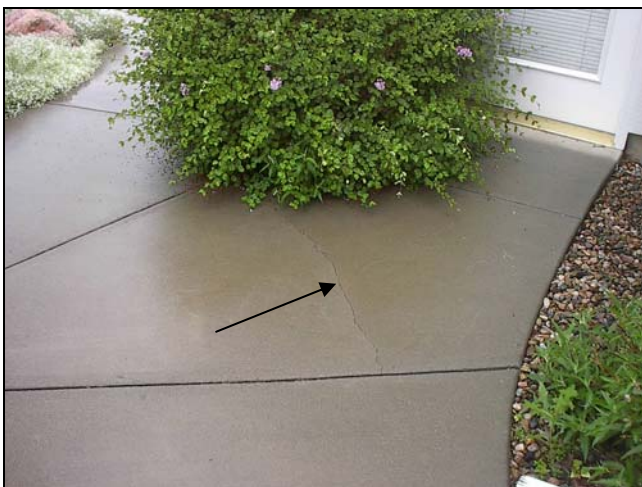
8. Driveway, front walkway, and front step display cracking. These cracks may be the result of swelling soil heaving or, alternatively, localized settling due to improper compaction of backfill. These cracks should be caulked to prevent access for water that accelerates the rate of heaving or settlement damage.

Crack in front walkway

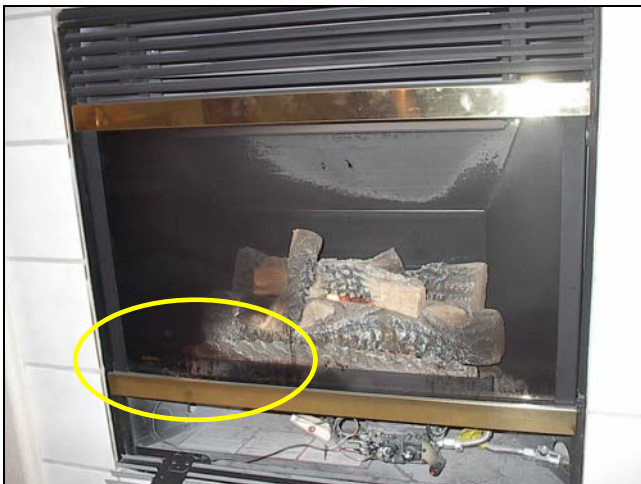
10. Soot and oxidation, i.e. whitish-brown residue evident on inside of the fireplace glass, may be indicative of a venting issue or incomplete combustion, which is a potential health safety hazard. This fireplace glass requires cleaning to manufacturer detail and the unit requires further evaluation by a qualified fireplace specialist.

Soot and oxidation evident

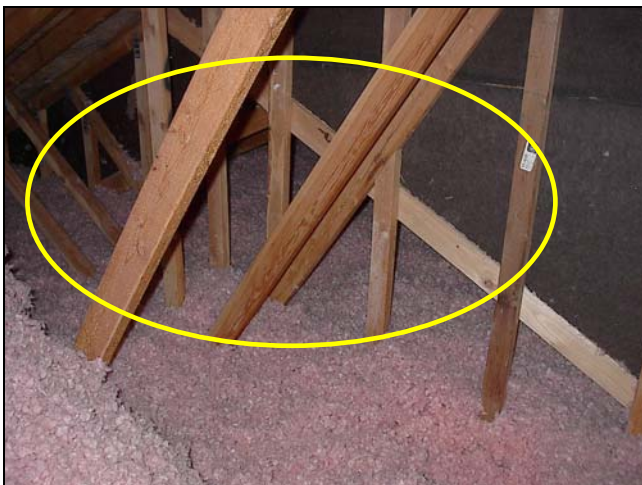
12. Access to the attic area above the master bathroom was restricted because of this home's roof construction style. Therefore, this component and its features may possess latent defects that were not detected during the inspection, and they may not. In this instance, the full extent of the condition of this structural component cannot be determined from this limited visual inspection.

Access to the attic area above Bath 1 was restricted
