National Inspection Services ©

Component Inspection

Subject Property: 2774 Nottingham Square, Fort Collins, Colorado

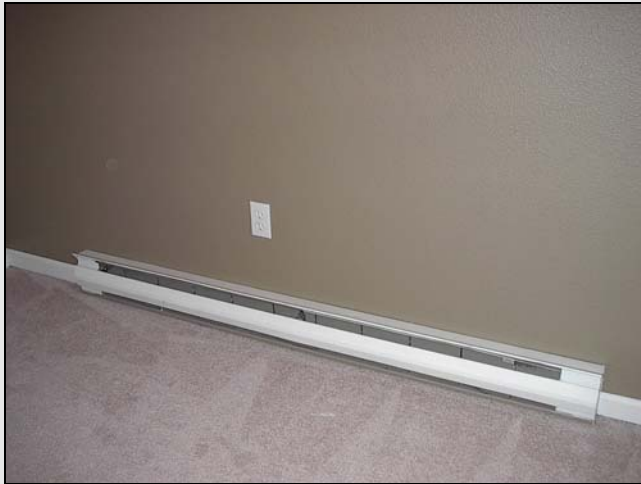
3. It is no longer considered an acceptable practice to locate outlets above baseboard heaters. Cords plugged into these outlets will tend to drape over the heaters and may overheat, which creates a fire hazard. In this instance, there are a number of outlets that have been located above baseboard units when this home was built. Because this report is not intended to be a review of building code compliance and since codes are not usually retroactive; strategy for cure, if any, should be consistent with future expectations.

Outlet above family room baseboard heating unit

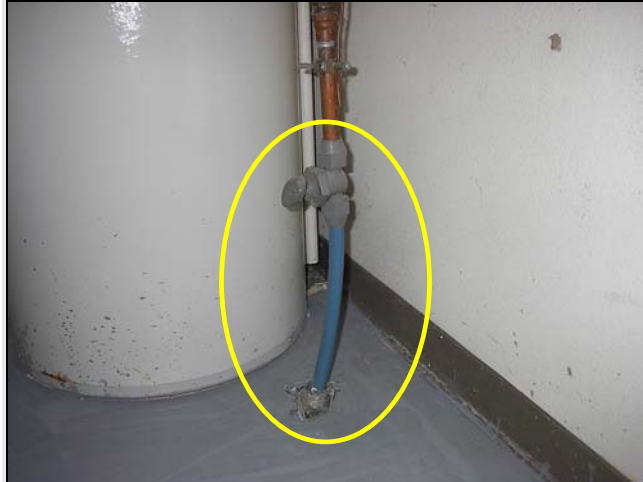
5. Main water supply line appears to be a polybutylene material, a form of plastic resin. Historically, there is a greater than average chance of failure with polybutylene material caused by either poor design or poor installation of crimp rings resulting in leaks. Reports suggest use of chloramines accelerates corrosion and degradation. For further information, please visit www.polybutylene.com. Replacement is recommended.

Main water supply line appears to be a polybutylene

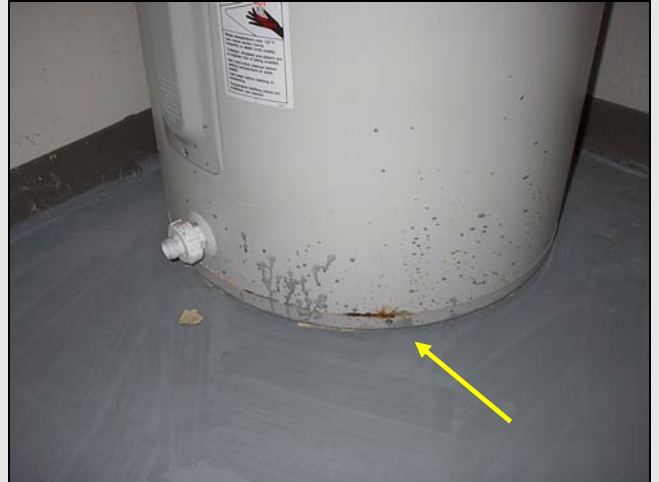
6. The water heater was functional; however, rust was evident, which is problematic in that rusting tanks are prone to leakage. Based on industry averages, water heaters of this approximated age are considered nearing or at the end of their service life. I recommend monitoring for future leaks or proactive replacement.

Rust on water heater

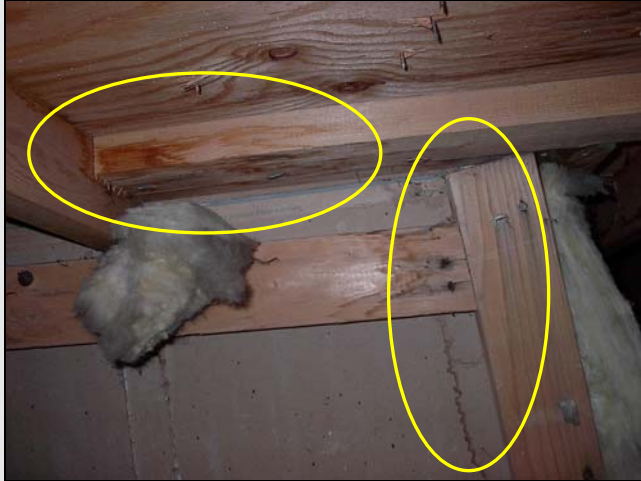
11. Evidence of watermarks on skylight well, sheathing (garage) and framing members (fireplace chimney) indicates previous and/or possible current water penetration not active at time of inspection and requires further review by a qualified contractor. Further evaluation by this qualified contractor may result in recommendations for corrective measures and additional costs that are beyond the scope of this inspection and report.

Watermark on framing and skylight well

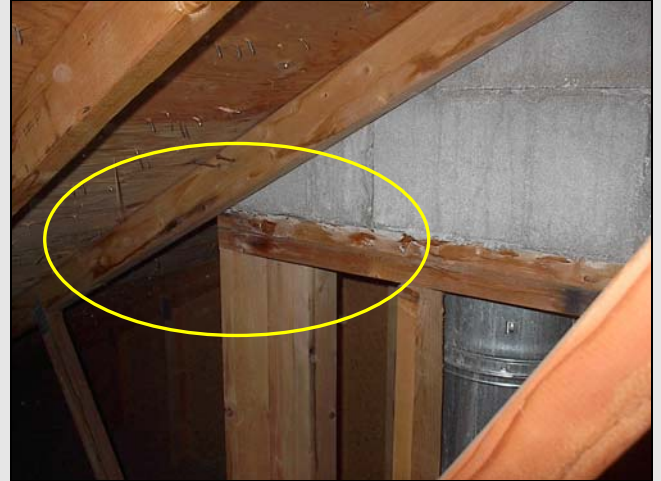
Watermarks on framing member at fireplace chimney

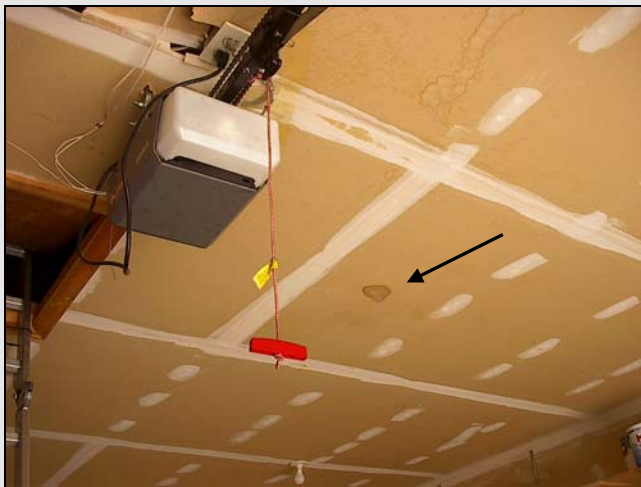
Watermark on garage ceiling
