# BUILDING INSPECTION REPORT

**INSPECTION ADDRESS: 914 Cherry Street  
Fort Collins, Colorado**

**CUSTOMER: Madson Holdings, LLC**

**INSPECTION DATE: July 7, 2010**

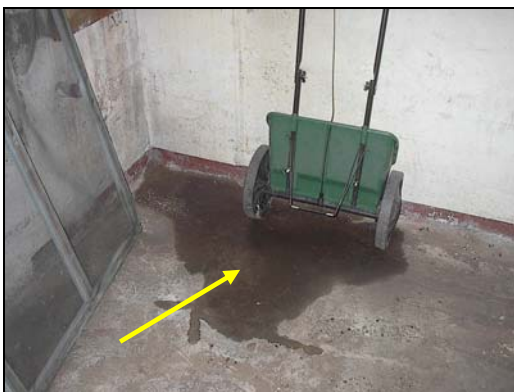
1. Active water penetration, southeast cellar. Improvement to roof drainage and grading is recommended (see Remark #29 and Remark #30) with continued monitoring.

Active water penetration in cellar

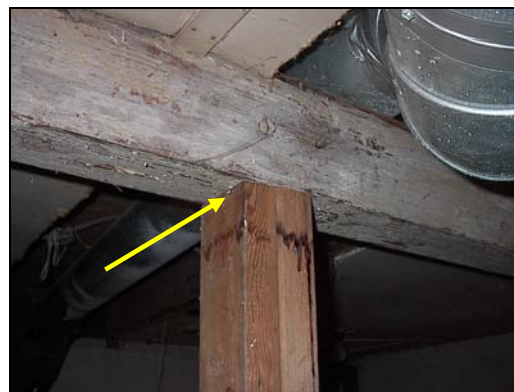
2. Support columns should be well secured to footings and to beams above. In this instance, wood posts were not secured to their respective wood beams above, creating poor connections. Differential movement between the beam and support post can result in catastrophic failure. Metal straps are recommended to secure these joints.

Support post is not properly secured to beam

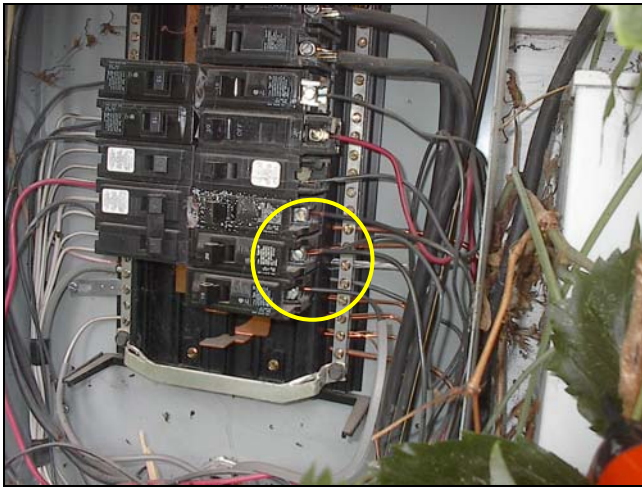
**Double tapped circuit**

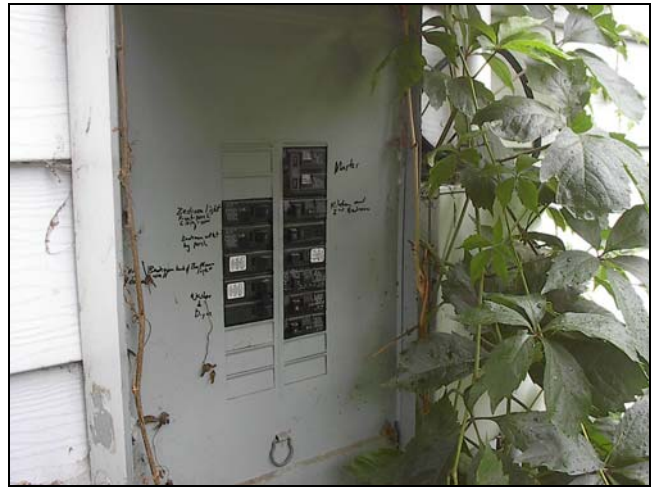
**Breakers at panel require complete and accurate labeling**

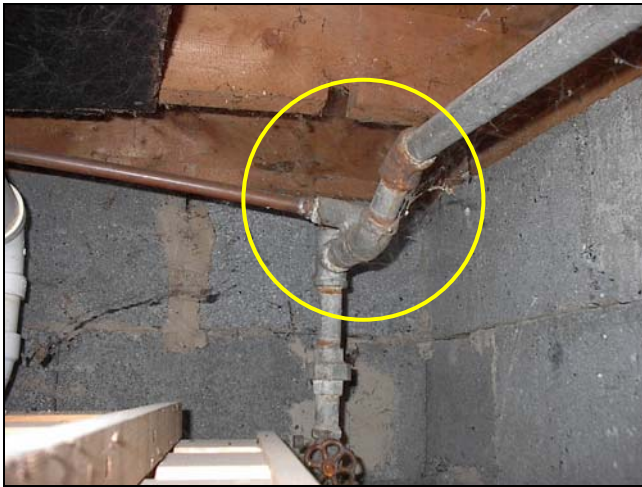
9. Mixed galvanized & copper supply piping can lead to galvanic action between the dissimilar metals. This is characterized by accelerated corrosion at the point of contact and leaking. Separation of these dissimilar metals utilizing a di-electric connector can avoid such problems. Further evaluation and adjustment by a qualified contractor is recommended.

**Mixed metals with rust evident near main shut-off valve**

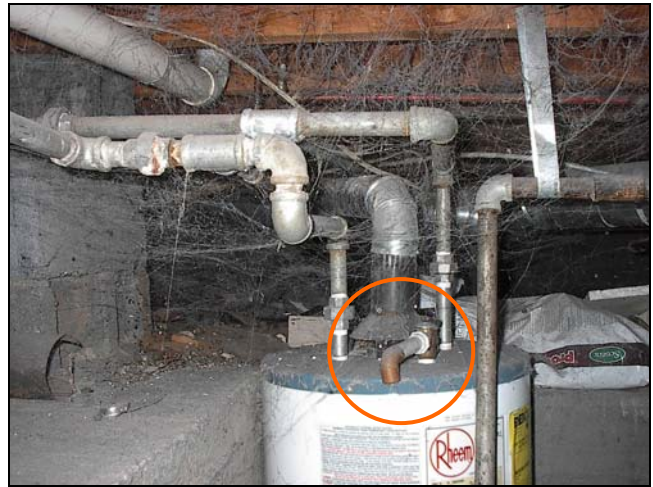
**Discharge tube for the water heater is absent**

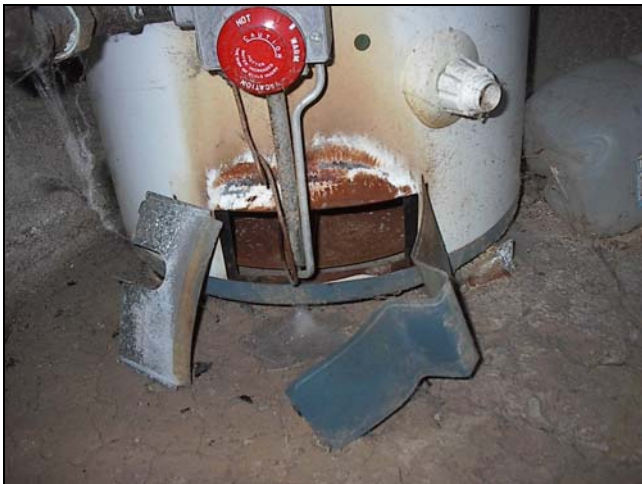
11. The water heater was functional; however, rust was evident, which is problematic in that rusting tanks are prone to leakage. Based on industry standards, water heaters of this approximated age are considered nearing or at the end of their service life. I recommend monitoring for future leaks or proactive replacement.

**Rust is evident at water heater**

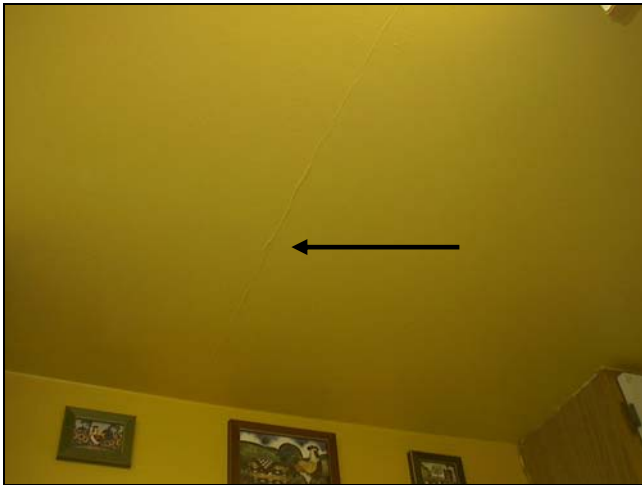
14. Ceiling in kitchen displays cracking, which appears to be inconsequential and does not appear to be a chronic or degenerative condition.
-

**Crack in kitchen ceiling**

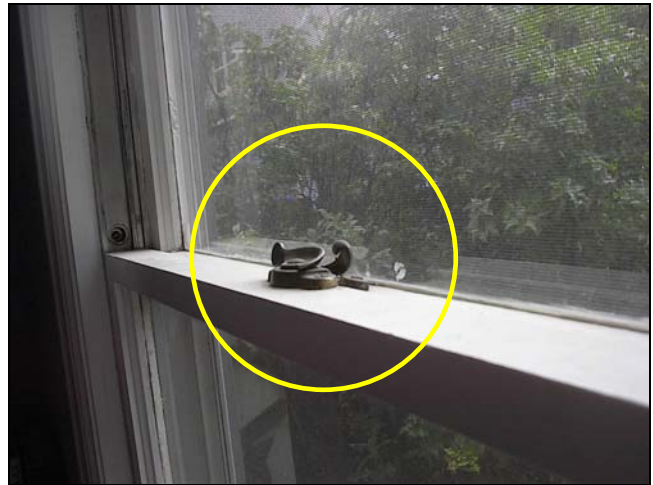
15. Window (north) in Bedroom 1 did not latch; window (adjacent to exterior exit door) in Bedroom 1 did not open as intended; and window in dining area with cracked window pane. Strategy for restoration, or cure should be consistent with intended use and future expectations. For safety reasons, latch for Bedroom 1 window should be repaired.

**This Bedroom 1 window cannot latch without repair**

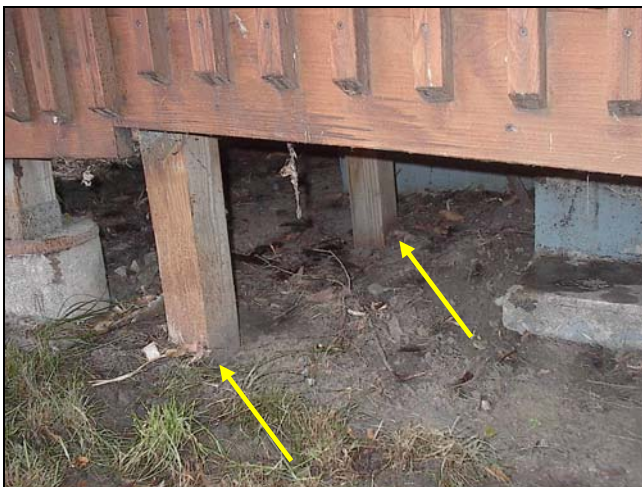
18. Wood deck support posts and handrail extend below grade or are otherwise in direct contact with the soil. Wood in contact with soil or below grade is problematic in that they historically do not experience a long life, particularly as a structural member. As a result, there are several design challenges with respect to wood piers, such as rot, termites and improper support. Adjustments are recommended.

**Wood support posts in contact with soil**

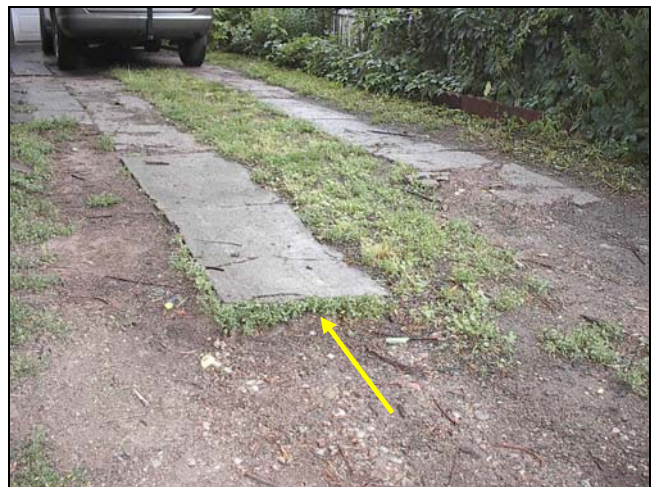
19. Driveway displays damage with sections missing and vertical displacement; which has created possible trip hazards that require repair or section replacements.

**Possible trip hazard**

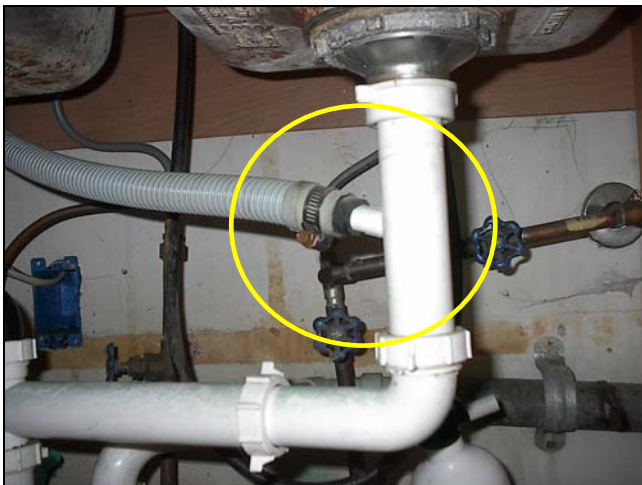
**21.** In many municipalities, the drain connection from a dishwasher has to be made using an appropriate air gap to prevent backflow resulting in contamination; however, different jurisdictions will have their own rules and codes will change over time. In this instance, the drain connection is problematic. While this current configuration may be tolerable; I recommend abandoning this arrangement and installing an air gap fitting or an acceptable alternative connection to prevent contamination in the event that waste backs up through the dishwasher drain hose.

**This drain connection is problematic**

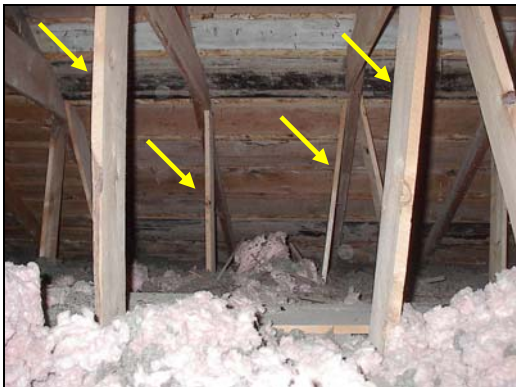
**26.** Unconventional reinforcement to rafters is apparent and may be a compensating feature, perhaps an afterthought. These alterations appear to be unconventional, substandard workmanlike solutions that may not conform to design expectations and may be deficient in performance. Since problems with these added purlin and/or supporting strut components may develop, resulting in future structural issues; I recommend further evaluation by a qualified contractor.

**Unconventional reinforcements**

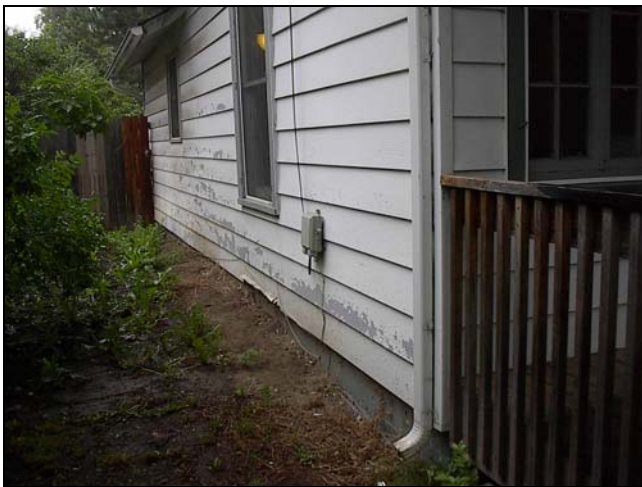
**28.** Peeling and/or worn paint of the siding is evident; which requires priming and re-painting. In addition, peeling and/or worn paint is evident at fascias, resulting in exposed wood; which require sanding, priming and re-painting.

**Siding requires priming and re-painting**

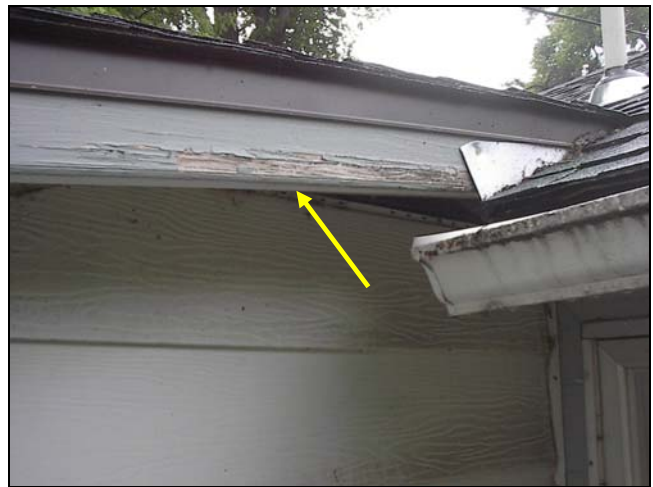
**Peeling paint with exposed wood**

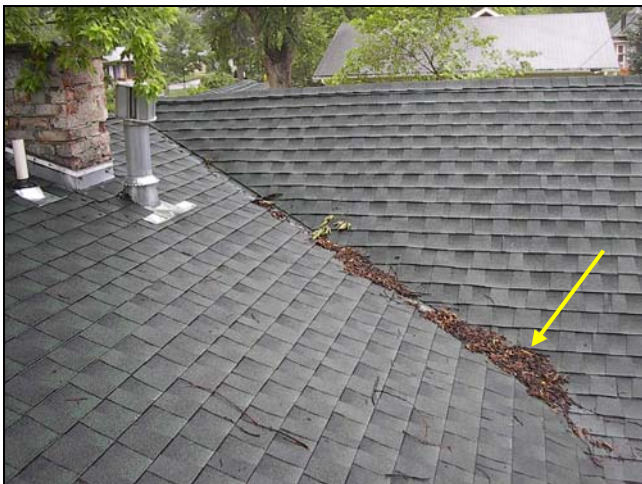
**Debris in valley can result in water intrusion into attic**

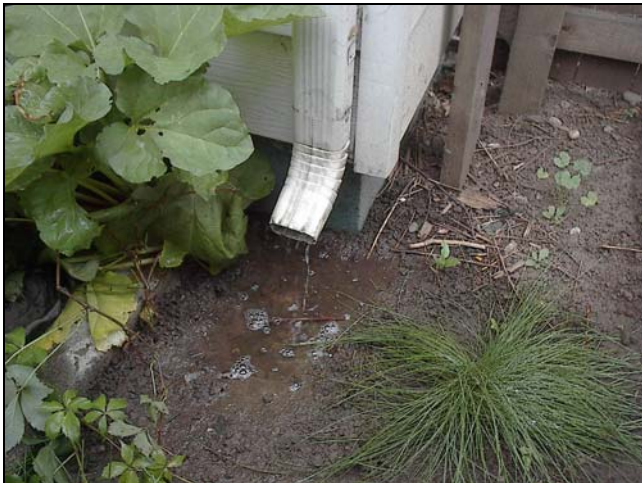
**30.** All downspouts require extensions or alternative drainage systems to adequately distribute water runoff away from the foundation. In this instance, any extensions absent from their respective downspouts require replacements.
-

**A downspout extension and grading adjustment needed**

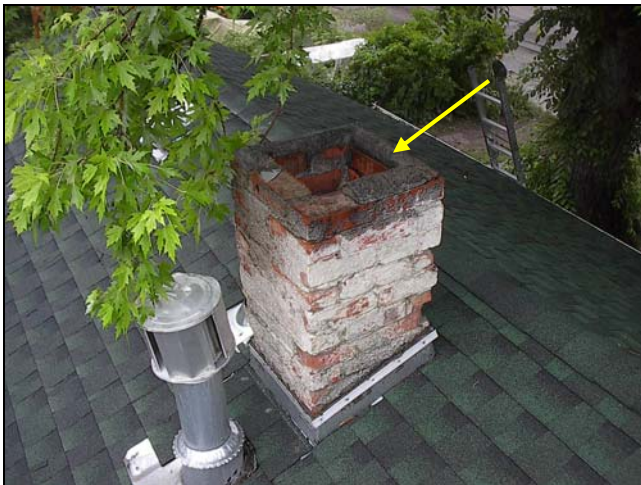
32. Mortar cap of brick chimney was partially absent, which requires repair. The implications of cracking or missing mortar caps are instability of top bricks, water leakage into the masonry components and deterioration of the top part of the chimney or structural components below.

33. Masonry chimneys typically require a storm or rain cap. The implications of absent caps are water leakage into the masonry components and deterioration of the top part of the chimney or structural components below. Even when chimneys are abandoned, storm caps keep rain, snow, birds, and animals out of the chimney.

**Mortar cap repair and a storm cap is recommended**

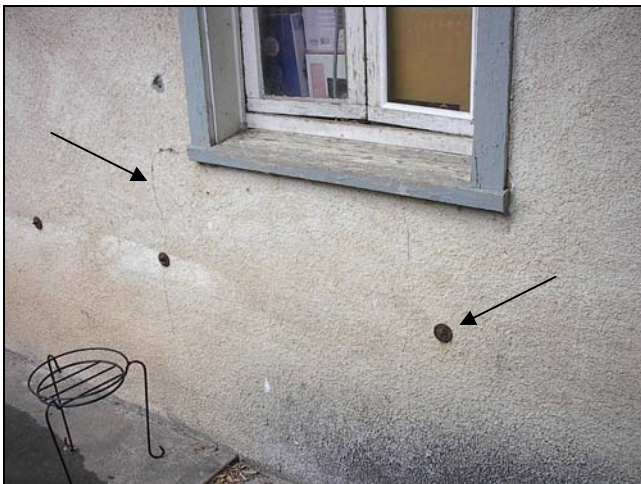
**34.** Cracking of the exterior stucco wall with supports added are evident; which suggest structural distress that does not conform to design expectations. Supports may be a compensating feature, perhaps an afterthought. This may be evidence of a component deficient in performance, and it may not. Further evaluation by a qualified engineer or contractor is recommended.

**Cracks in exterior walls of garage with supports evident**
