# BUILDING INSPECTION REPORT

**NATIONAL INSPECTION SERVICES**

**INSPECTION ADDRESS:** 415 W. 10<sup>th</sup> Street  
Loveland, Colorado

**INSPECTION DATE:** July 19, 2010

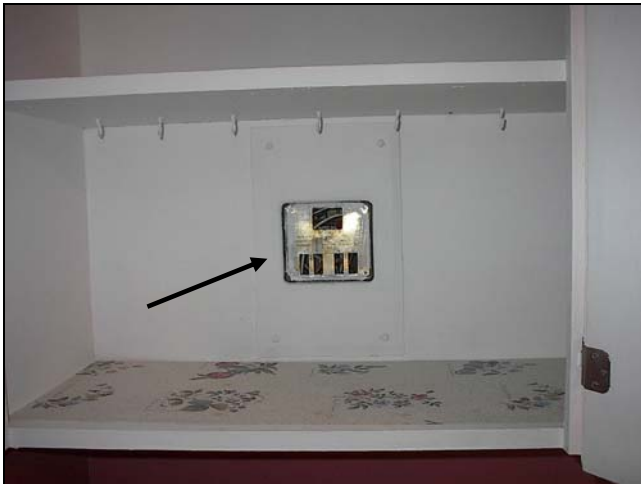
Abandoned panelboard with open slots

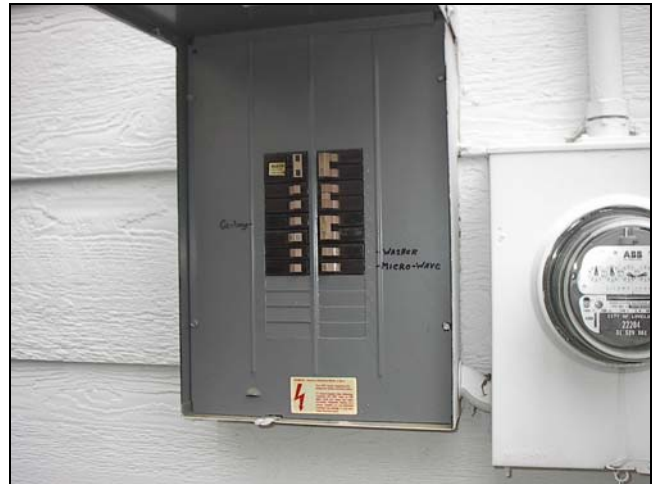
1. I recommend GFCI (ground fault circuit interrupter) protection for receptacles located in bathrooms, garages, kitchens, crawlspaces, and unfinished basements; and in certain locations such as near outdoor spas or hot tubs. Also, the main distribution panel requires accurate labeling of all breakers.
-

Complete labeling of the main panel is important

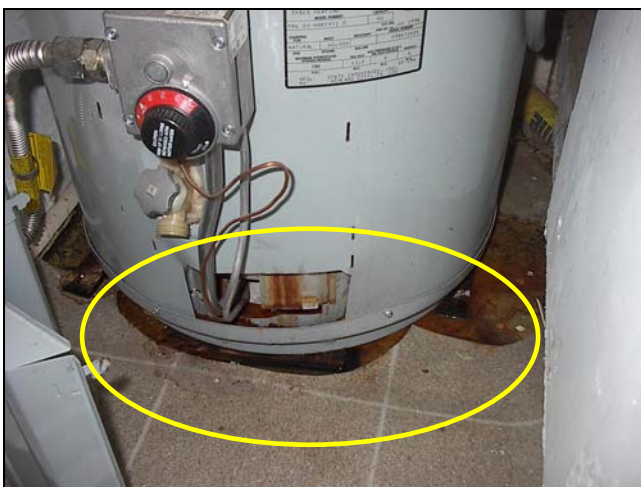
7. An active leak was observed at the water heater and on the wood floor beneath the water heater. Although this water heater was serviceable, water leakage and rust evident on the tank are indications that this water heater is at the end of its service life. I recommend replacing the water.
-

**Rust and water leak evident at water heater**

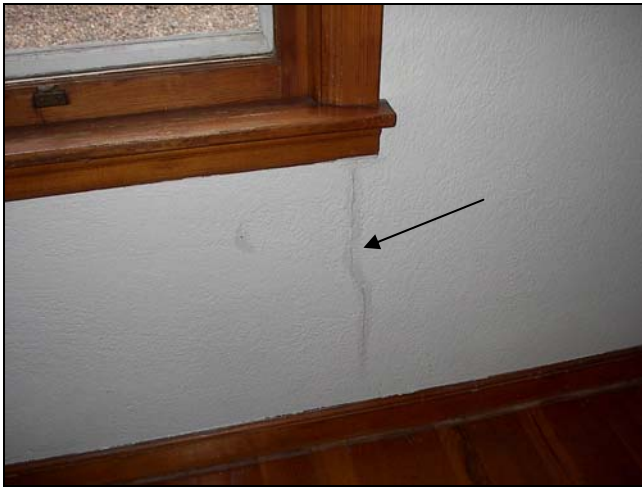
9. Walls and ceilings displays cracking, which appear to be inconsequential and do not appear to be chronic or degenerative condition.

**Crack in wall below window of Bedroom 2**

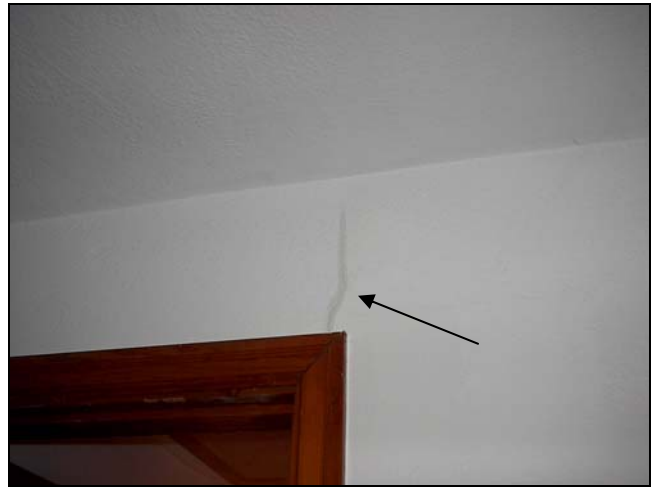
**Crack in wall above Bedroom 2 door**

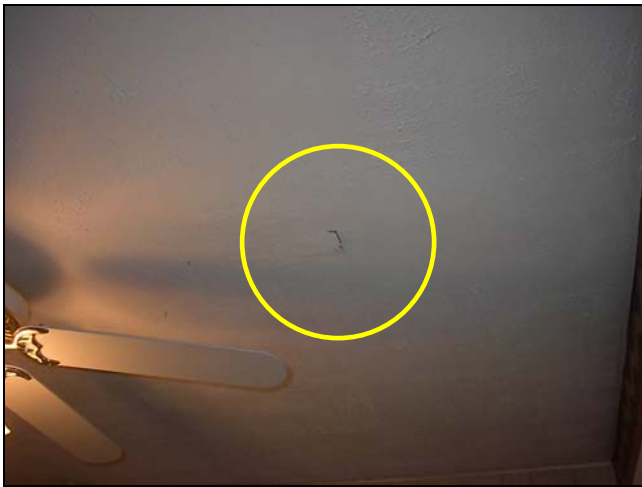
10. Blistering paint at the kitchen ceiling is a typical symptom of moisture. Testing for moisture content of this ceiling did not result in an elevated moisture reading. A water leak from the attic above could not be ruled out (see related comments in Remark #18). Further investigation is recommended.

**Blistering paint in kitchen ceiling**

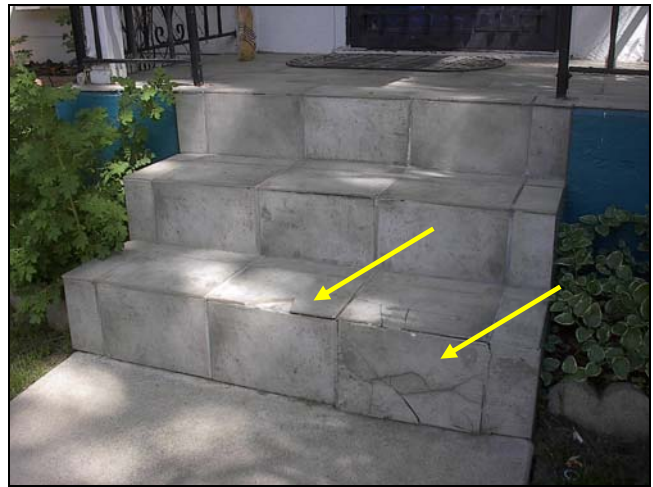
13. Cracked and chipped tile at the front step is evident. This damaged tile is an egress issue that creates a possible trip hazard, and requires repair or tile replacement.

**Damaged tile at front step**

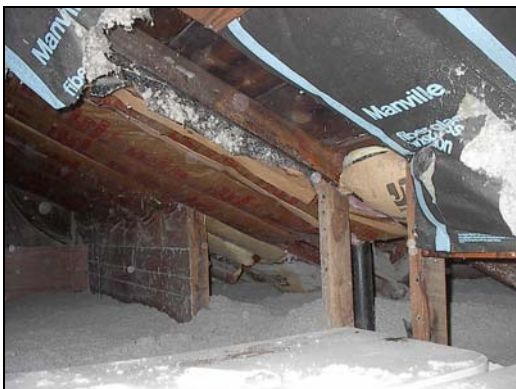
18. Access to the attic area above the family room, dining room and kitchen, was restricted because of this home's low slope roof construction and remodel construction, respectively. Therefore, these areas and their features may possess latent defects that were not detected during the inspection, and they may not. In this instance, the full extent of the condition of this structural component cannot be determined from this limited visual inspection. Monitoring is recommended.

**Restricted access in attic**

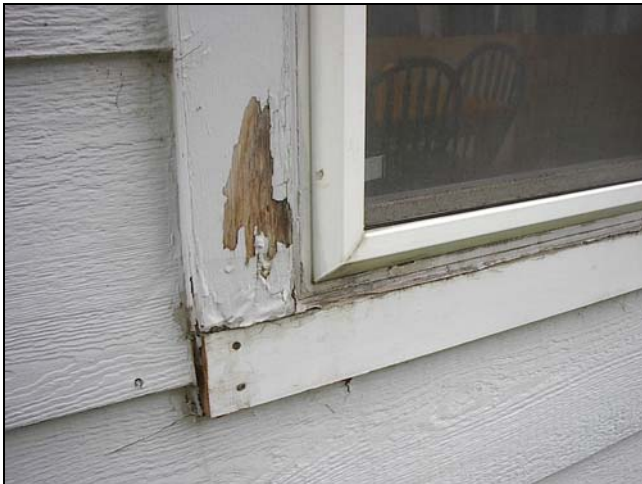
**20.** There is evidence of water penetration and damage to window framing on the west side of the house. Replacement of water damaged wood, re-sealing, priming and painting is required. Latent water intrusion may have created defects of wood member hidden by the siding, which could not be detected during the inspection, and they may not. In this instance, the full extent of the condition of these items cannot be ascertained from my limited visual inspection without a destructive evaluation.

**Water damaged wood window frame**

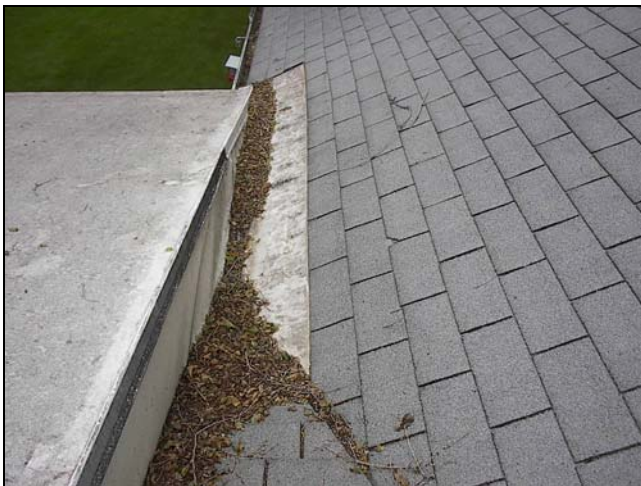
23. Debris in roof valleys can cause damming, which may result in water backup and intrusion; and latent damage. Removal of debris is required.

Debris in roof valley of dissimilar surfaces

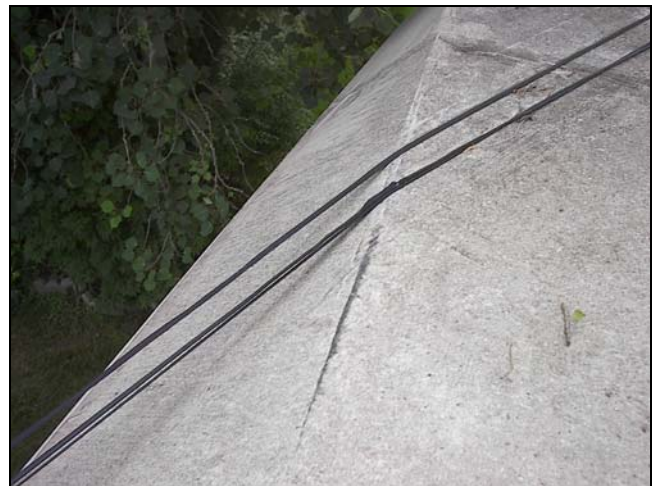
22. Low hanging telephone wires are in contact with the single ply roof, which can result in failure of this roofing material through mechanical abrasion. Adjustments are recommended. Also, the plane of the main roof and garage is not straight, which may be indicative of a latent structural issue.

Failure may result due to mechanical abrasion
