BUILDING INSPECTION REPORT

**INSPECTION ADDRESS: 1705 Heatheridge Road
Units C201, C205, D203 and H104
Fort Collins, Colorado**

INSPECTION DATE: July 26, 2010

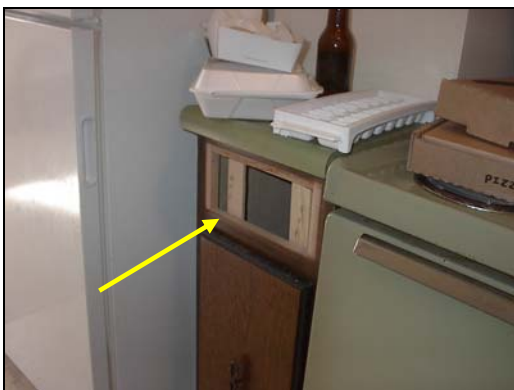
9. Damage to Unit #C-201 kitchen cabinet requires repair.
-

Damaged kitchen cabinet face – Unit #C-201
