BUILDING INSPECTION REPORT

NATIONAL INSPECTION SERVICES

**INSPECTION ADDRESS: 1700 Larch Street
Fort Collins, Colorado**

INSPECTION DATE: July 27, 2010

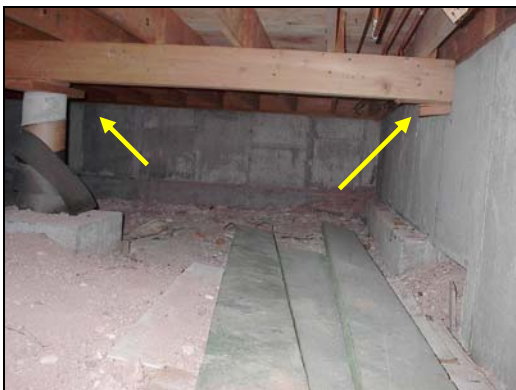
3. Beam support in beam pocket is less than 3-inches and may not conform to design expectations and may be deficient in performance, and they may not be deficient. Furthermore, wood beams can sit on wood shims, although they should provide continuous bearing on the top and bottom of the shim. The shims should be secured in place with adhesive or mechanical fasteners. The shims should be of wood at least as hard and dense as the beams. In this instance, adequate bearing is suspect because the beam is supported by unsecured shims. In this instance, further review by a qualified engineer is advised.

Bearing in beam pocket and shims are suspect

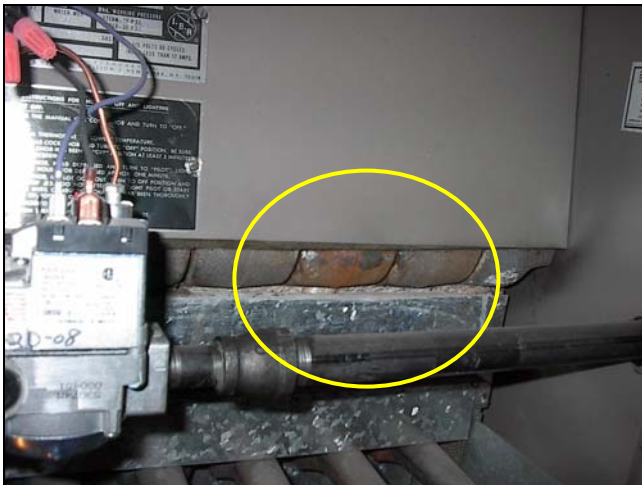
5. Rust was evident near the heat exchange of the boiler as well as on its external components. Rust on a heat exchange can lead to leaks. Also, rust on the fire side of the heat exchanger reduces the boiler's efficiency, increases the heating costs and may clog the exhaust gas passages, leading to life threatening spillage of exhaust gases into the building. Due to its stated Scope; this inspection is not intended to be technically exhaustive; therefore, I recommend a comprehensive safety and system evaluation by a qualified contractor.

Rust near heat exchanger of boiler

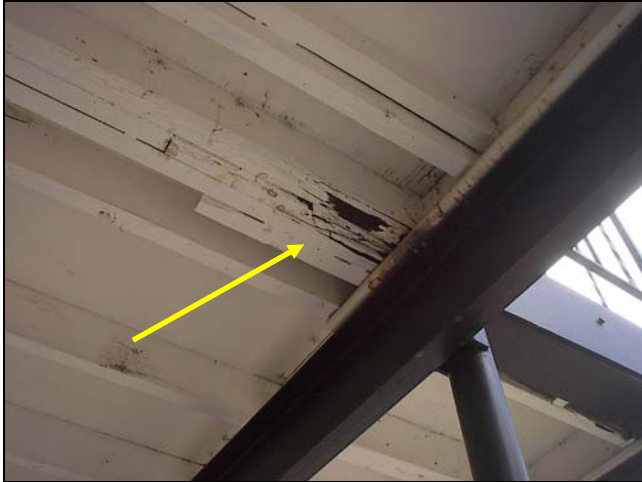
21. Balcony joists are water damaged. The implication is joists that can lose their support over time. As a result, there are several design challenges with respect improper support, which can result in failure. Repair or replacement is required.

Balcony joists are water damaged

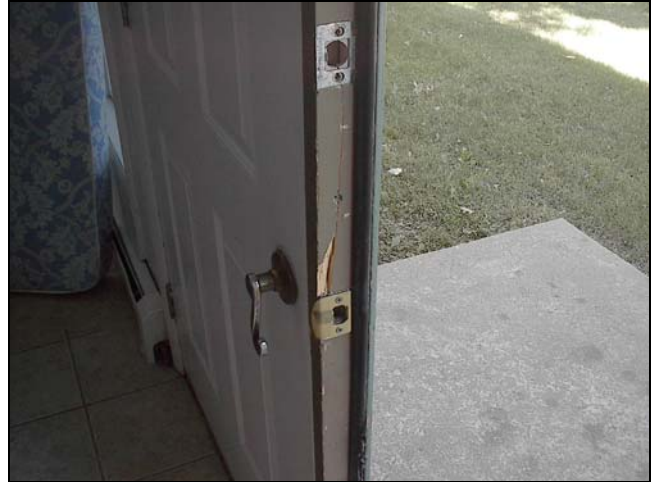
18. Some tiles of the foyer floor (at main front entrance) is cracked, which requires repair. Door to common foyer (main front entrance) is damaged and requires repair or replacement.

Damaged front entrance door

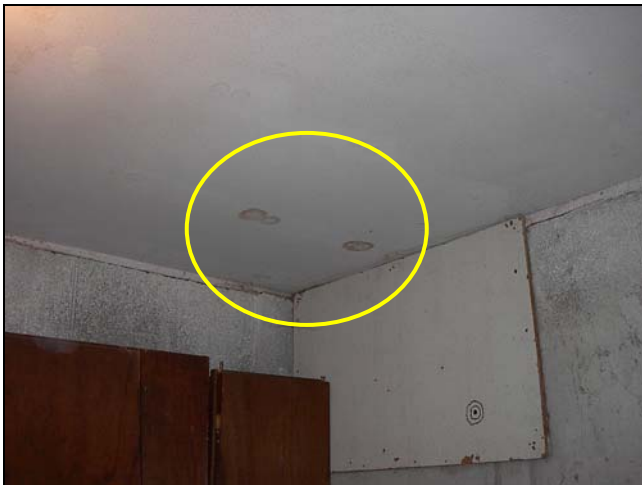
17. Watermarks were apparent on the ceiling and walls of the mechanical room and on the ceiling of the southeastern most storage area near the south crawlspace. Using a limited moisture meter, the inspector confirmed elevated moisture content of the ceiling surface near the entrance to the south crawlspace, indicating possible latent water intrusion from above. Further evaluation is required to determine the source and extent of any water related issues.

Elevated moisture content at these watermarks

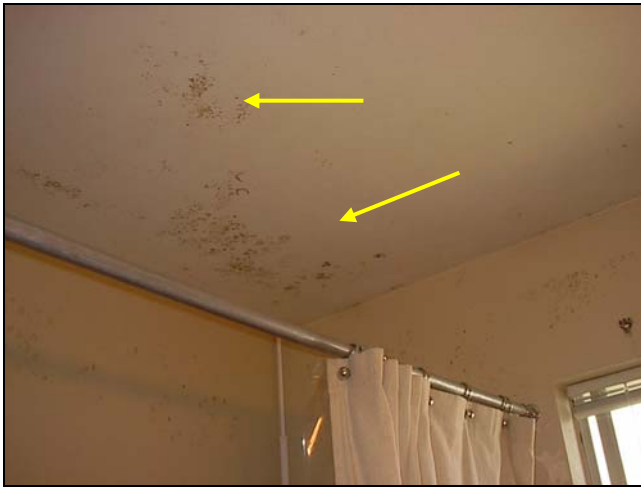
29. Mold-like substances were visible on **Unit C** bathroom ceiling. Discoloration and stains on the walls were evident, making these areas suspect. Because there can be potential health and structural issues with mold; I recommend a mold inspection, testing and assessment performed in accordance with ACGIH (American Conference of Governmental Industrial Hygienists) standards by National Inspection Services or another IESO trained inspector knowledgeable in proper IAQA (Indoor Air Quality Association) indoor air quality protocols.
-

Mold-like stains on **Unit C** bathroom ceiling

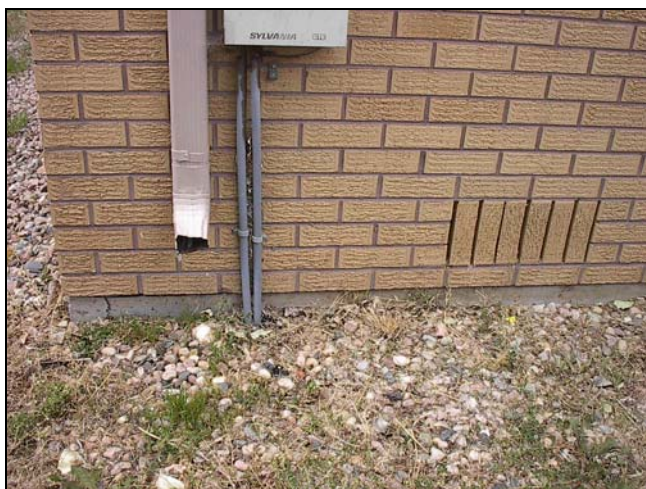
34. All downspouts require extensions or alternative drainage systems to adequately distribute water runoff away from the foundation. In this instance, any extensions absent from their respective downspouts require replacements.

All downspouts require extensions
