BUILDING INSPECTION REPORT

**INSPECTION ADDRESS: 8747 Country Road 98
Nunn, Colorado**

INSPECTION DATE: August 5, 2010

Structure Type:	Detached single family residence, 1-story Ranch
Approximate Year Built:	2001
Foundation Type:	Full crawlspace

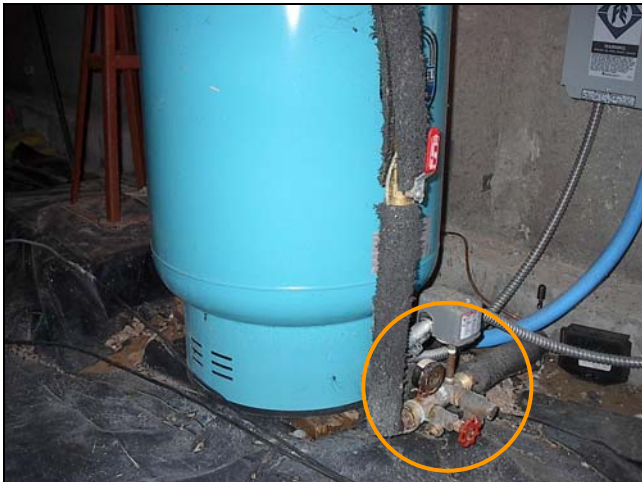
**6b.** The 44 gallon storage tank located in crawl space appeared serviceable; however, rust is evident. This is problematic in that rusting tank components are prone to leakage. In this instance, a possible water leak is suspected, which requires further evaluation of a qualified contractor.

Rust is evident

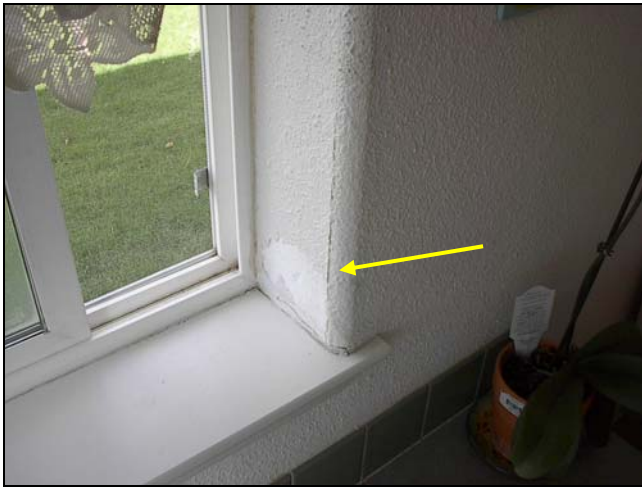
7. Walls in Bath 1, Bedroom 1, Bedroom 2 and Bedroom 3 display cracking, which appear to be inconsequential and do not appear to be chronic or degenerative conditions. Ceiling in Bath 2, displays cracking, which appears to be inconsequential and does not appear to be a chronic or degenerative condition. Monitoring is recommended.

Cracking evident in Bath 1

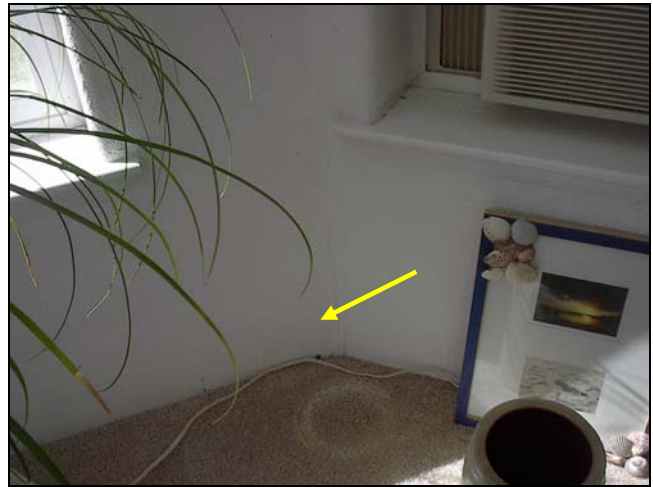
Cracking in Bedroom 1

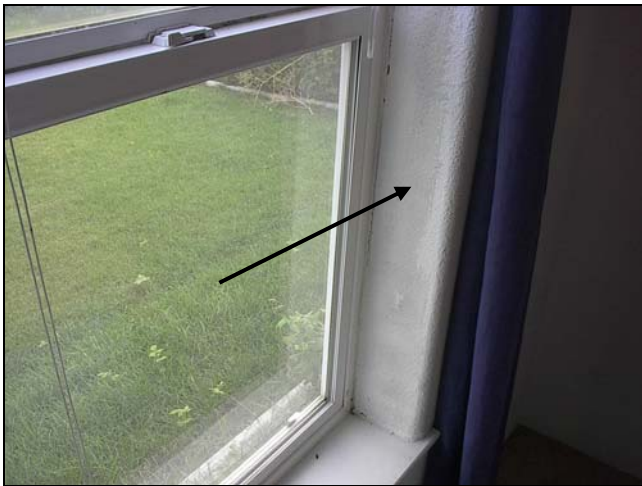
8. Discoloration at the window of Bedroom 4 suggests water intrusion. Further investigation is recommended using a noninvasive evaluation method that utilizes infrared thermography for hidden conditions because trapped moisture can effect the integrity of structural components.

Discoloration suggests water intrusion at window

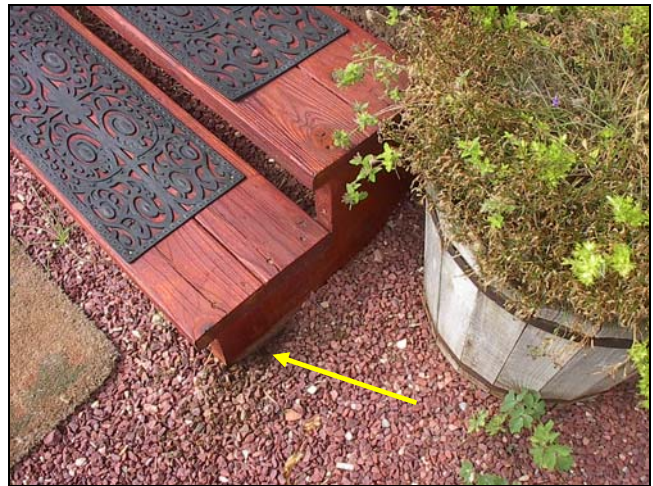
11. Some wood deck support posts and the front stair stringers extend below grade or are otherwise in direct contact with the soil. Wood in contact with soil or below grade is problematic in that they historically do not experience a long life, particularly as a structural member. As a result, there are several design challenges with respect to wood piers, such as rot, termites and improper support. Adjustments are recommended.

Wood in contact with soil at front step

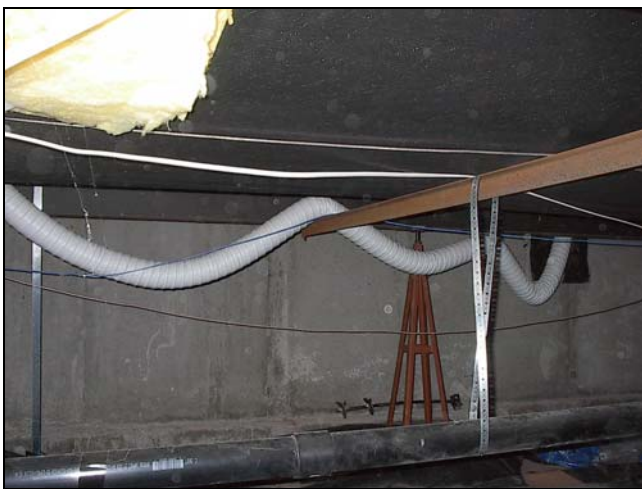
14. Laundry: Lack of maintenance is the major factor contributing to clothes dryer exhaust system fires, although improper duct material also plays a role. In this instance, the flexible vinyl transition duct has a negative slope, as observed from the crawl space, resulting in restrictive airflow that creates a trap for lint to collect or to back up. The exhaust system requires cleaning. Also, it is advisable to use only UL-approved transition duct material, preferably a smooth metal material (not plastic or corrugated) and always follow the dryer manufacturer's recommendations.

Dryer duct has a negative slope

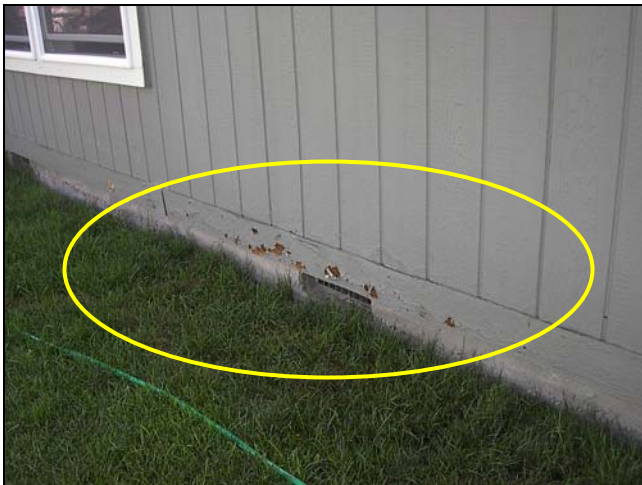
**18.** There is evidence of water absorption and damage to the composition trim and siding on the west side of the house. Section replacement, repairs and re-sealing is recommended.

Evidence of water absorption and damage

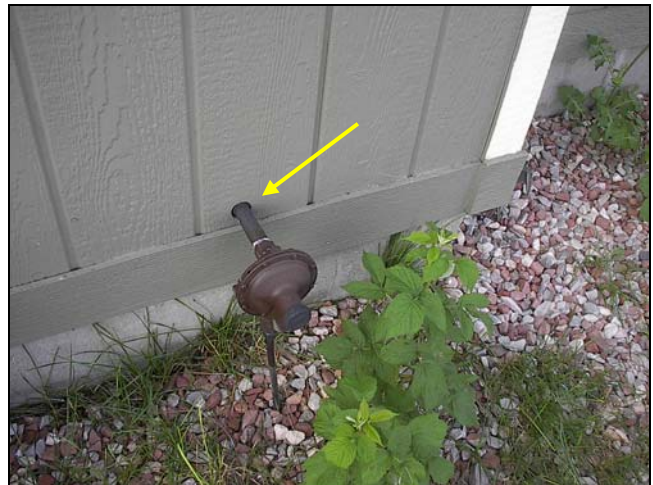
**17.** Sealant is absent at mechanical penetrations. All penetrations require sealing. Sealing prevents water penetration or absorption, which can result in delamination and damage.
-

All penetrations require sealing
