National Inspection Services ©

August 12, 2010

Component Inspection

Subject Property: 312 Maddies Way, Cheyenne, Wyoming

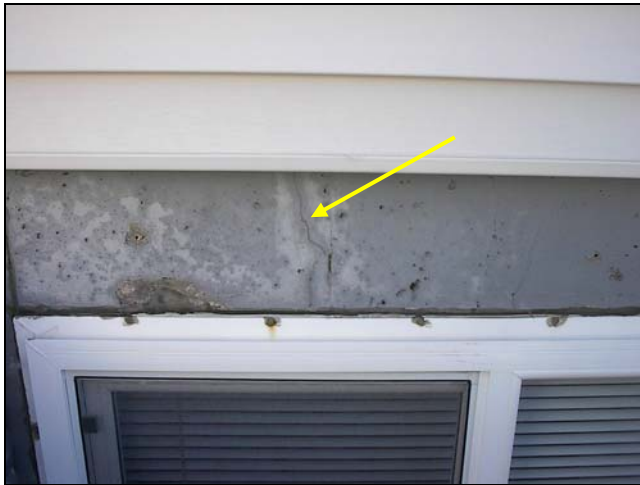
1. Cracking is evident in concrete foundation wall. These cracks may not be indicative of a chronic or degenerative condition and require monitoring.

Cracking is evident in concrete foundation wall

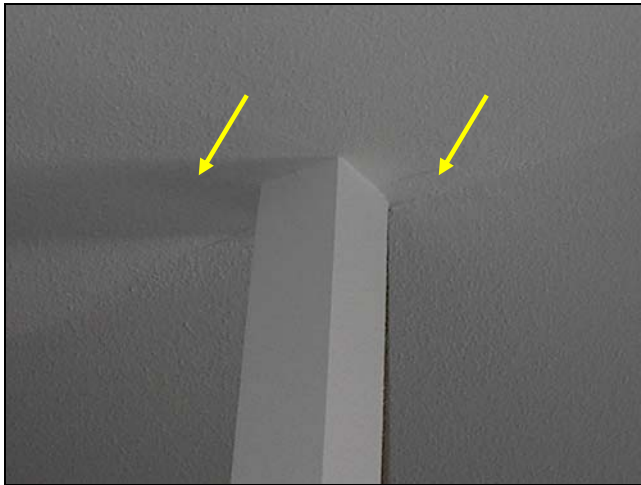
2. Ceiling in the Living Room displays cracking, which appears to be inconsequential and does not appear to be a chronic or degenerative condition. Monitoring is recommended.

Cracking of living room ceiling (east view)

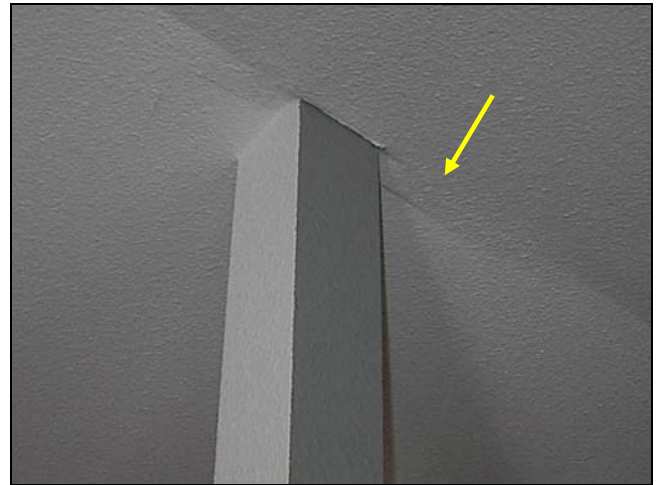
Cracking of living room ceiling (west view)

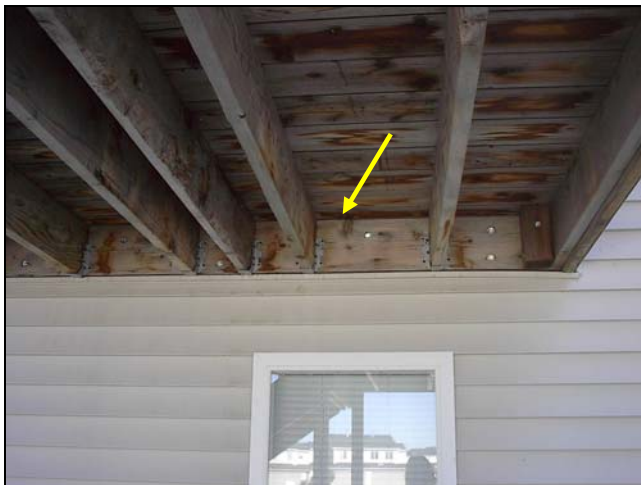
4. Flashing at the deck's ledgerboard was not apparent, which may lead to eventual water penetration and damage of structural components where the deck attaches to the structure's framing. Monitoring is recommended.

Flashing not evident at ledgerboard

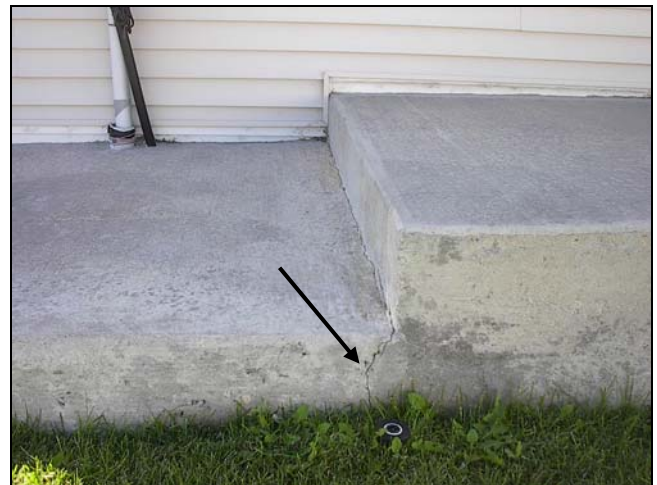
5. Front walkway and rear patio display cracking. These cracks may be the result of swelling soil heaving or, alternatively, localized settling due to improper compaction of backfill. These cracks should be caulked to prevent access for water that accelerates the rate of heaving or settlement damage.

Crack at front walkway

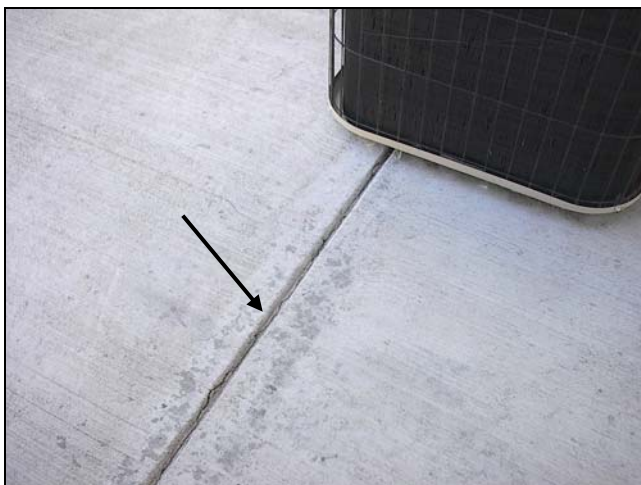
Crack in control joint at rear patio
