BUILDING INSPECTION REPORT

**INSPECTION ADDRESS: 7324 Tamarisk Drive
Fort Collins, Colorado**

INSPECTION DATE: August 20, 2010

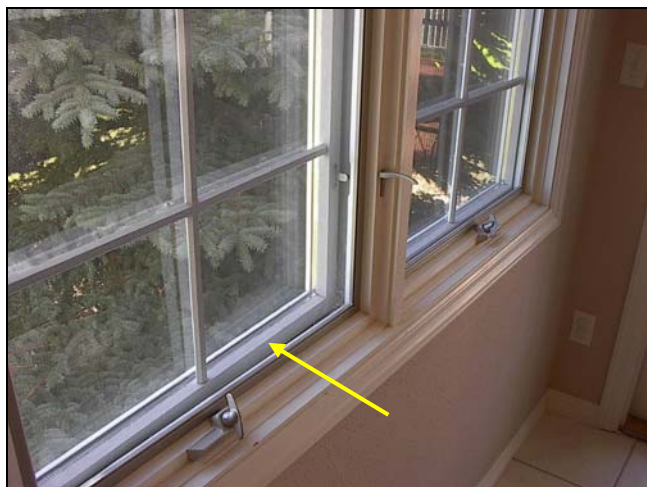
Peeling paint at window frames

**14.** Peeling and/or worn paint is evident at deck beams and window frames, resulting in exposed wood; which require sanding, priming and re-painting.

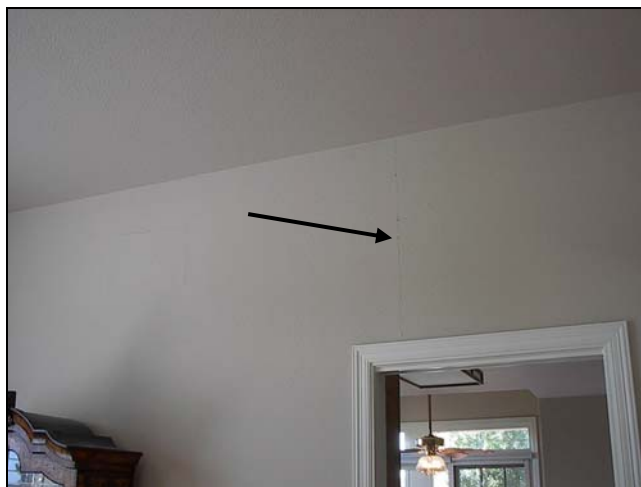
4. Walls in dining room and living room (at beam) display cracking, which appears to be inconsequential and does not appear to be a chronic or degenerative condition.

Crack in dining room wall

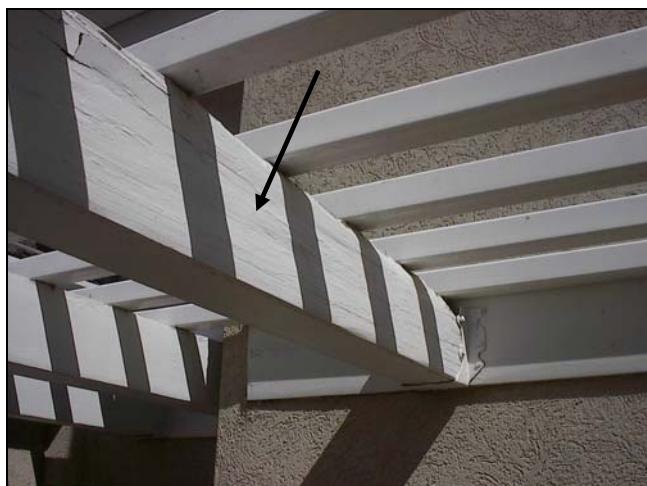
7. Wood beam above deck is water damaged and requires replacement.

Water damaged wood beam at deck

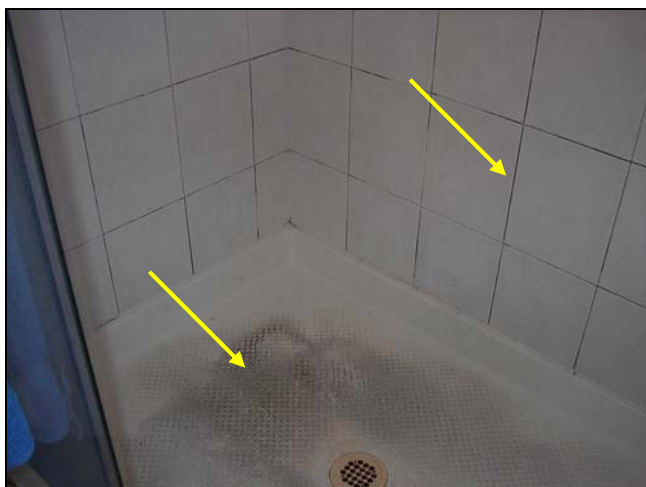
9. Discoloration of Bath 1 shower floor and tile wall grout is evident, which requires cleaning per manufacturer's detail. Consult with a qualified contractor as shower floor pan may be beyond adequate cleaning and may require replacing.
-

Discoloration of shower floor and grout

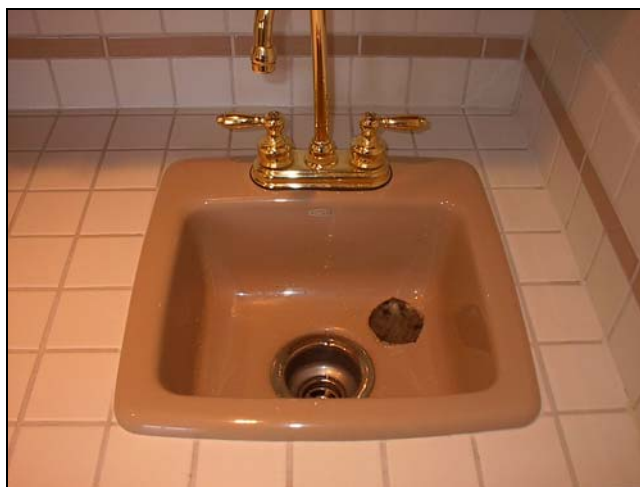
10. Wet bar sink is damaged and requires a replacement.

Damaged sink in wet bar

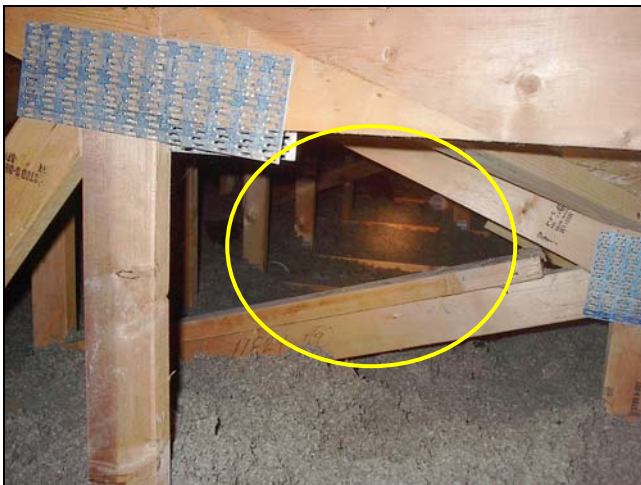
11. The purpose of insulation is to slow the rate of heat transfer. Recommended insulation levels for ceiling insulation is R-38. The approximate R-value of mineral wool loose fill is 3.1 per inch. In this instance, the estimated average insulation levels are less than recommended and an additional application of insulation is advisable to increase the attic's thermal efficacy.

Levels of insulation less than adequate above Bdrm. 2

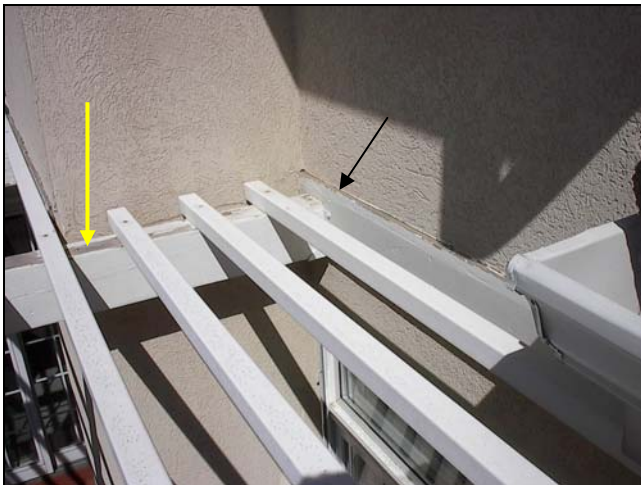
**12.** The stucco siding displays the following issues: absent or separated sealant at dissimilar materials, mechanical penetration damage, and absent or separated sealant at penetrations such as television dish bracket fasteners. These issues require repair and/or improvement to manufacturer detail. Proper corrective action will prevent water penetration that may result in latent water damage to structural components hidden by the stucco.

Sealant required at stucco and wood ledger
Peeling paint and exposed wood (yellow arrow)

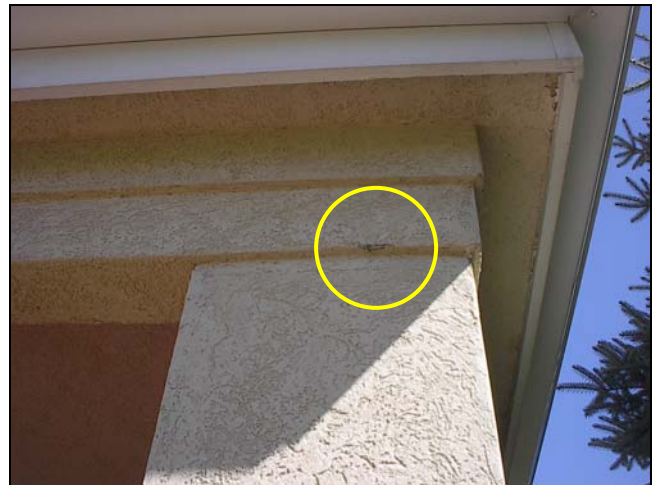
Damaged stucco requires repair per manufacturer detail

**13.** The stucco siding may conceal latent issues, and it may not. In this instance, the full extent of the condition of the stucco siding cannot be determined from my limited visual inspection. I recommend further evaluation by a certified EDI stucco specialist that may consist of possible intrusive testing of this siding. (Reference: www.exterior-design-inst.com EDI website)

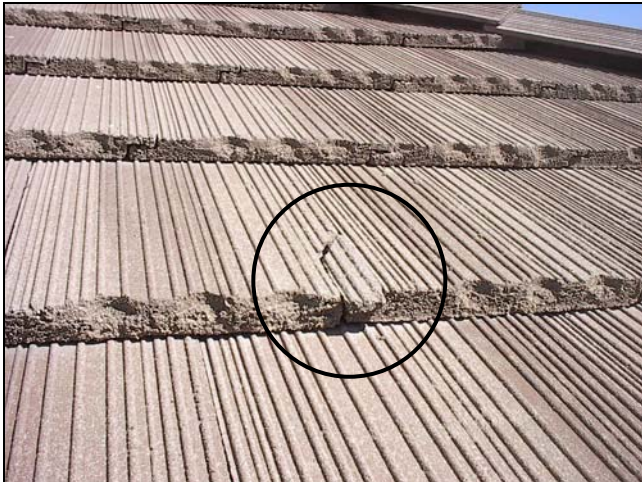
15. Some roof tiles were cracked or otherwise damaged, which require repair.

Damaged roof tile
