BUILDING INSPECTION REPORT

NATIONAL INSPECTION SERVICES

**INSPECTION ADDRESS: 8791 – 87th Street (aka Airport Road)
Longmont, Colorado**

INSPECTION DATE: August 31, 2010

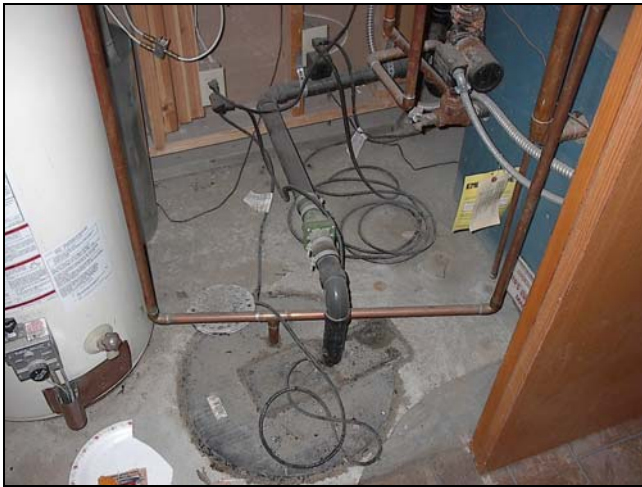
1. A sealed sump system with a viewable port, located in the mechanical room, was present. The system contained a pit reservoir, an indeterminate perimeter drain system that flows to the sump pit by gravity drainage, and a submersible automatic pump that removes collected water through discharge piping to the exterior. The pit itself contained no standing water. Because this was a sealed system, the pump could not be activated manually; therefore, representation about the functional condition of the complete sump system cannot be made. I recommend periodic monitoring of water levels within the sump pit and testing of the sump pump.

Sealed sump system in mechanical room

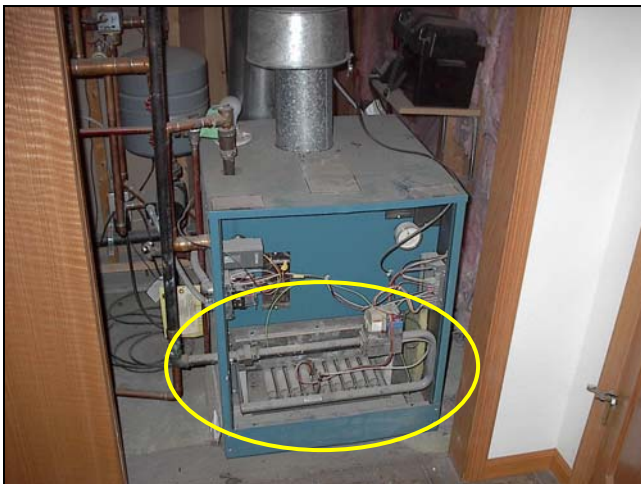
3. Although the boiler was serviceable, its burner was dirty. I recommend that a qualified HVAC contractor perform a standard maintenance and full system evaluation to ensure the efficient and safe operation of the heating system.

Burners require regular maintenance

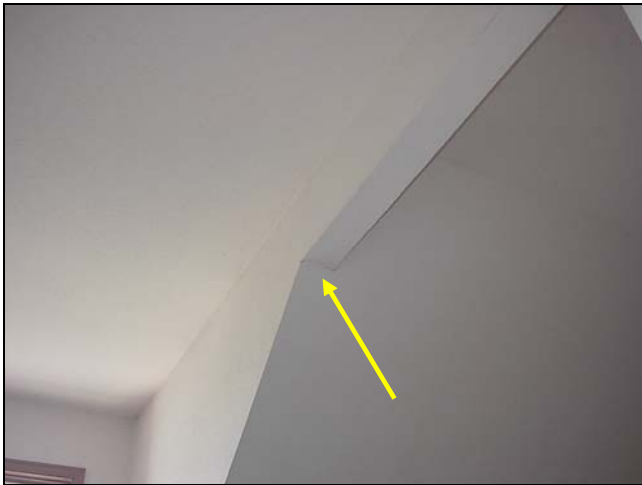
7. Wall in sun room and ceiling in living room display cracking, which appear to be inconsequential and does not appear to be a chronic or degenerative condition.

Crack in living room ceiling / wall intersection

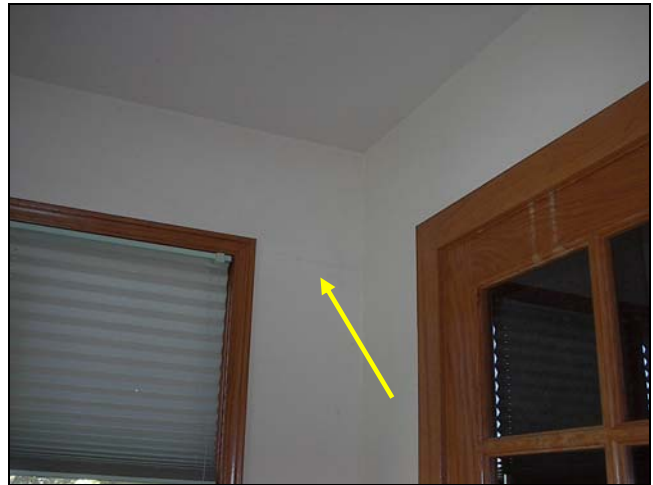
Crack in sun room wall

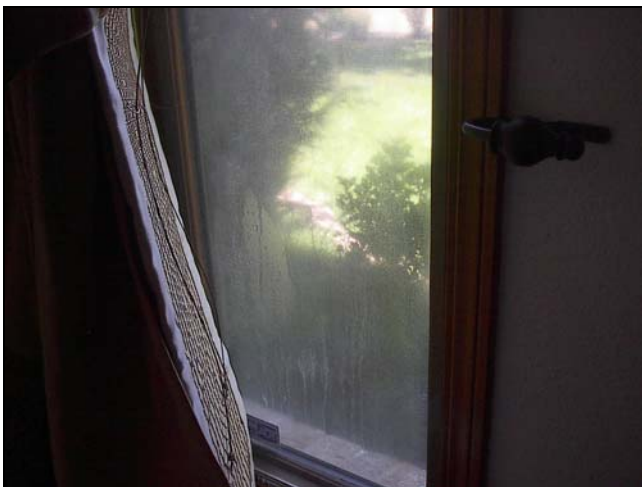
9. Condensation and/or remnants of moisture between the panes of a sealed, multi-glazed window indicate a failed seal. In this instance, the seal of a double-glazed in living room and Bedroom 3 windows have failed, allowing moisture penetration between the two panes, which reduce the thermal effectiveness and the appeal of these windows. Replacement is the recommended solution.

Window seal has failed in this living room window

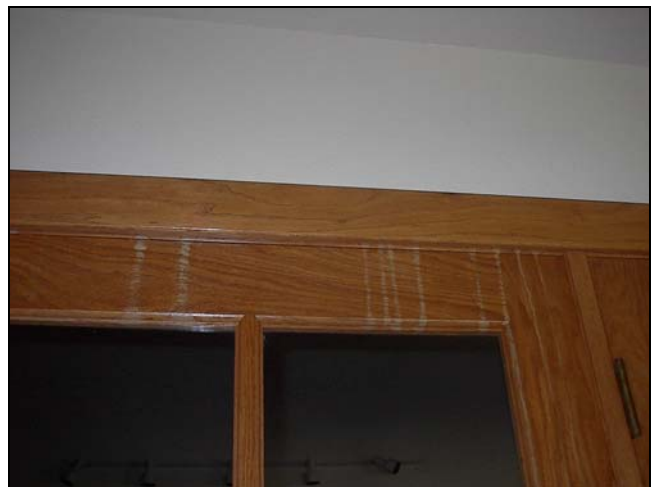
8. Evidence of discoloration, apparently watermarks, on the door frame of the sun room is evident and possible discoloration on the dining room ceiling. Both suggest previous and/or possible current water leaks. Conclusive evidence of the source of these watermarks could not be determined from this limited visual inspection. Further investigation is recommended using a noninvasive evaluation, which utilizes infrared thermography, to confirm or rule out hidden issues. Unresolved water intrusion can damage structural components or nurture mold and insect infestations.

Discoloration on door entering sun room

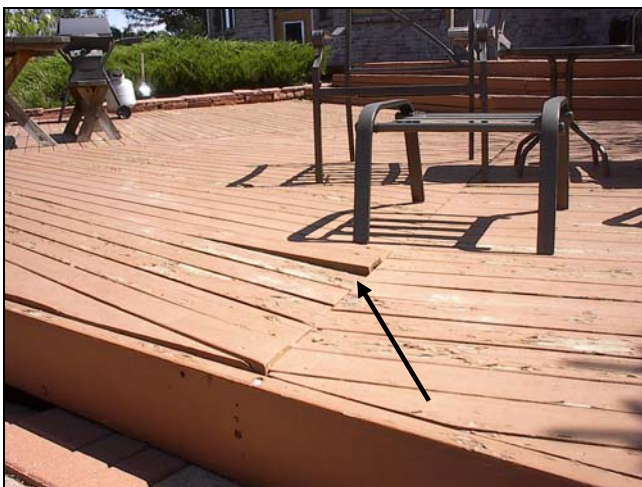
10. The deck requires an application of protective wood sealant. You should consider any wood deck that employs a wood preservative or comparable sealant as a temporary situation and the deck will be an ongoing maintenance item. Also, some deck boards are displaced, which create possible trip hazards and require repair.

Deck requires sealant and repair to deck boards (trip hazard)

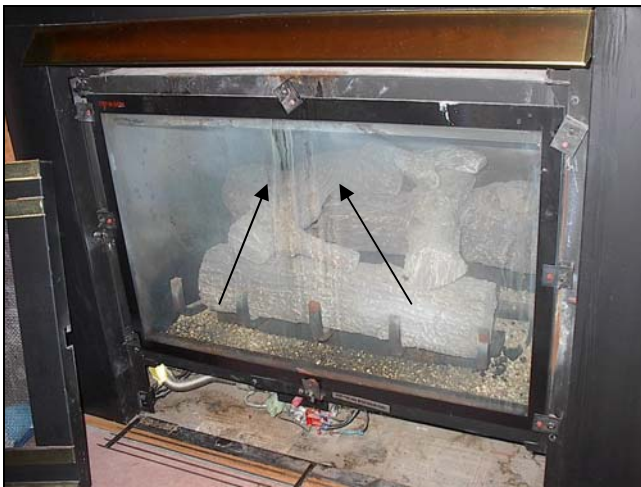
**13.** Oxidation, i.e. whitish-brown residue evident on inside of the glass, may be indicative of a venting issue or incomplete combustion, which is a potential health safety hazard. This fireplace glass requires cleaning to manufacturer detail and the unit requires further evaluation by a qualified fireplace specialist.

Evidence of oxidation

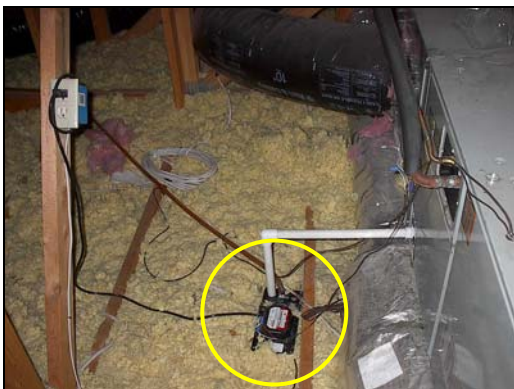
**17.** Sump pump system to remove air conditioner condensate requires regular maintenance at this time. Excessive noise or vibration from sump pump is evident and suggests issues, which require an adjustment or replacement of the unit. Water damage may result from systems not maintained as a result of condensate overflowing the pump's reservoir or damage from blocked discharge piping.

Sump pump at A/C unit

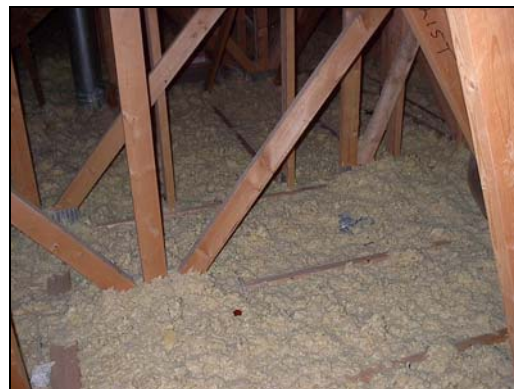
**16.** The purpose of insulation is to slow the rate of heat transfer. Recommended insulation levels for ceiling insulation is R-38. The approximate R-value of fiberglass loose fill is 3.0 per inch. In this instance, the estimated average insulation levels are less than recommended and an additional application of insulation is advisable to increase the attic's thermal efficacy.

Inadequate levels of insulation

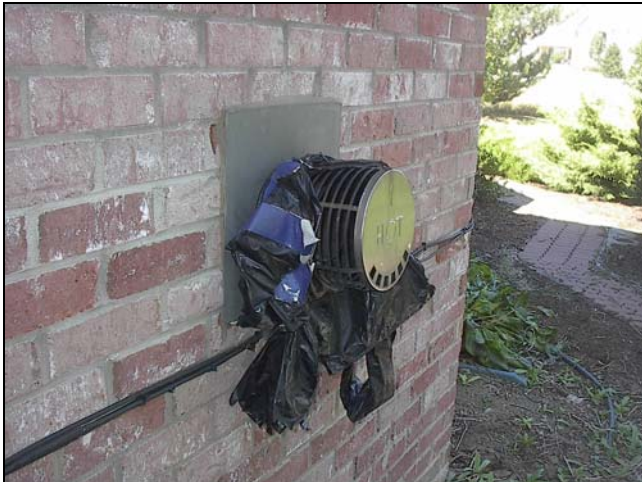
Chimney cover requires removal during use of fireplace
